Notice of Alteration Form

Please find attached the Notice of Alteration Form and all required documentation in respect to attached Inspection Report for the Ethelbert Lagoon, dated October 16, 2020.

**RE: Ethelbert Lagoon Dike Assessment Letter Report**

JR Cousin Consultants Ltd. (JRCC) has completed this letter report assessing the Ethelbert wastewater treatment lagoon dike condition in response to an inspection conducted by Manitoba Conservation and Climate in October 2020.

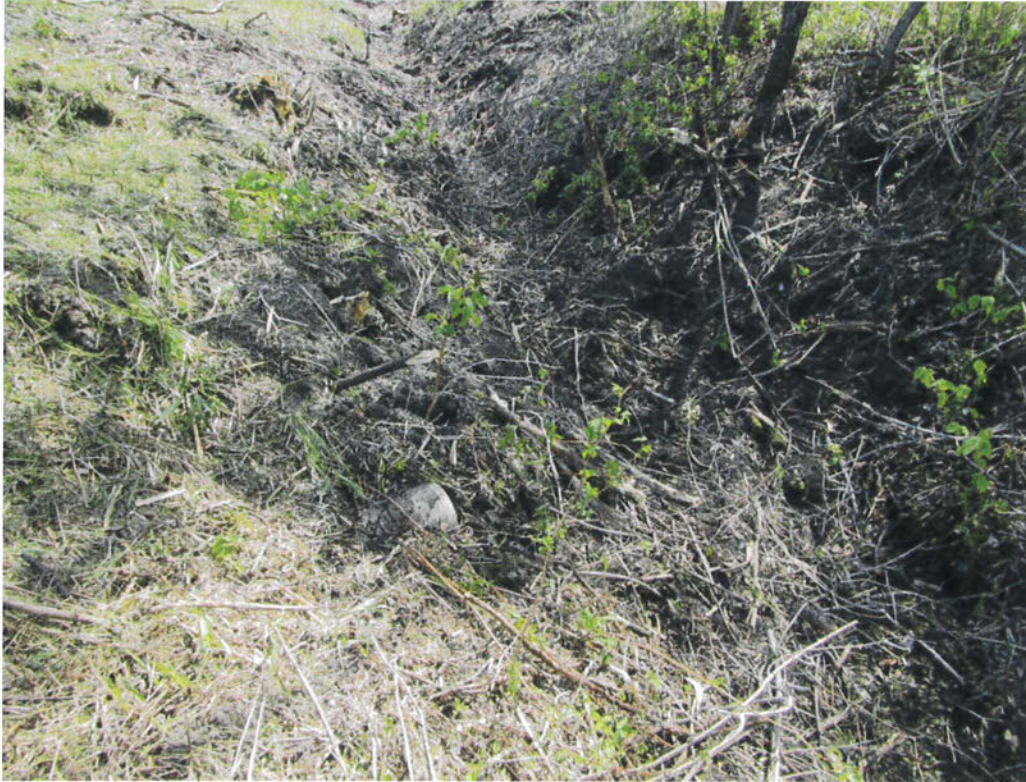
The investigation occurred after the storage cell had been drained, to expose the inner slope of the storage cell. No significant erosion was observed along the inner slope of the south dike. However, an additional abandoned drainage pipe was located through the dike that the operator was unaware of. This pipe was located at a depth of approximately 1.5 m below the top of dike, near the location of the existing cell drainage pipe. Both ends of the pipe were observed and the pipe appeared to go through the dike at an angle, along with a second pipe observed sitting on top of the first pipe on the outer dike slope (see location plan). There was evidence of moist conditions near the exit of this additional pipe on the outer slope, however as the pipe was no longer submerged in liquid due to the cell being drained, there was no liquid actively draining from the pipe. Photos of the abandoned pipes have been attached.

If the ponding liquid observed outside of the south dike was lagoon effluent, then it is likely that the source of the leak was from the additional abandoned discharge pipes. The abandoned discharge pipes are likely creating a permeable channel through the dike and potentially releasing wastewater when the lagoon level reaches the pipe elevation, at a height of 1.5 m below the top of the dike, which is consistent with the operator's observations of the ponding.

Photo 1: Abandoned discharge pipe on outer slope

The Municipality of Ethelbert would like to conduct the repair to the abandoned pipe by way of capping with adhesive as suggested by Mr. Wohlgemut, Environmental Scientist from JR Cousin. We feel this will satisfactorily alleviate the issue of leakage. In addition, we will pack and fill any low lying areas with clay to alleviate any standing water issues going forward. With approval, we are hoping to have this work conducted as soon as possible and before we get too deep into winter.

It is recommended that the Municipality remove the potential source of a lagoon cell leak by removing the abandoned pipes. If the pipes are removed, the lagoon liner in the excavated dike would need to be restored with high plastic compacted clay soils. The Municipality can attempt to cap the discharge pipe on both ends, however this may not resolve the issue if the discharge pipe is damaged and effluent is permeating through the soils around the pipe. Therefore, pipe removal is recommended rather than pipe capping. The lagoon operator should make observations of the area of concern during the summer months while the lagoon storage cell fills up with effluent, to determine if the location of a leak can be further clarified.

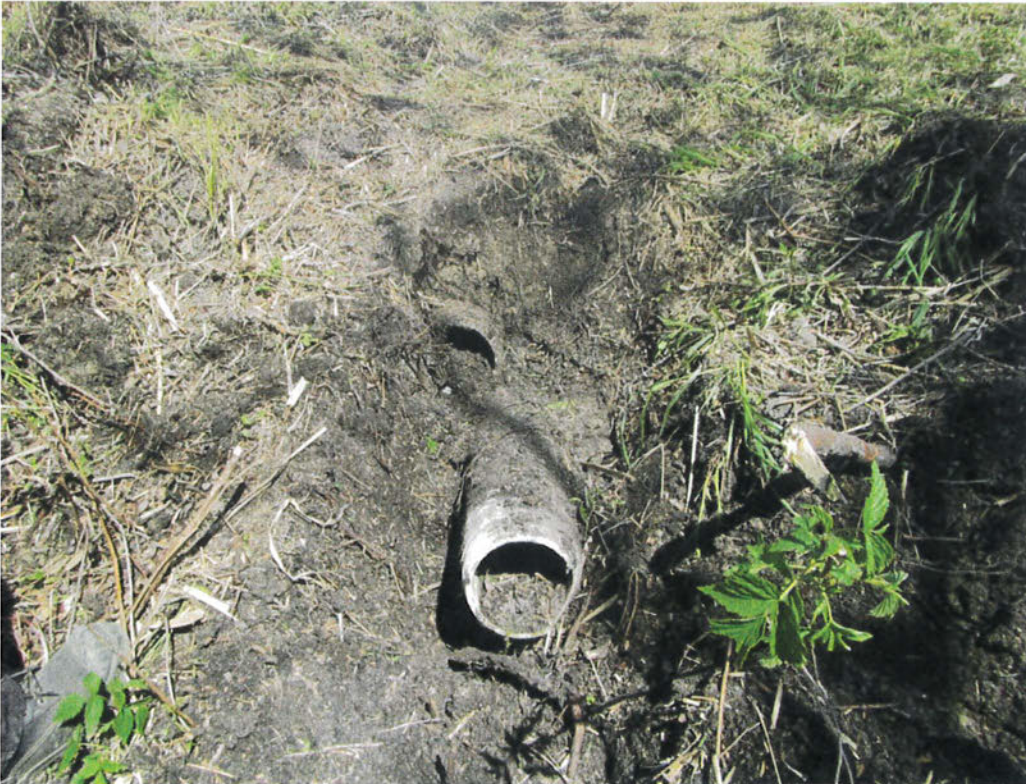
Photo 2: Abandoned discharge pipes on outer slope

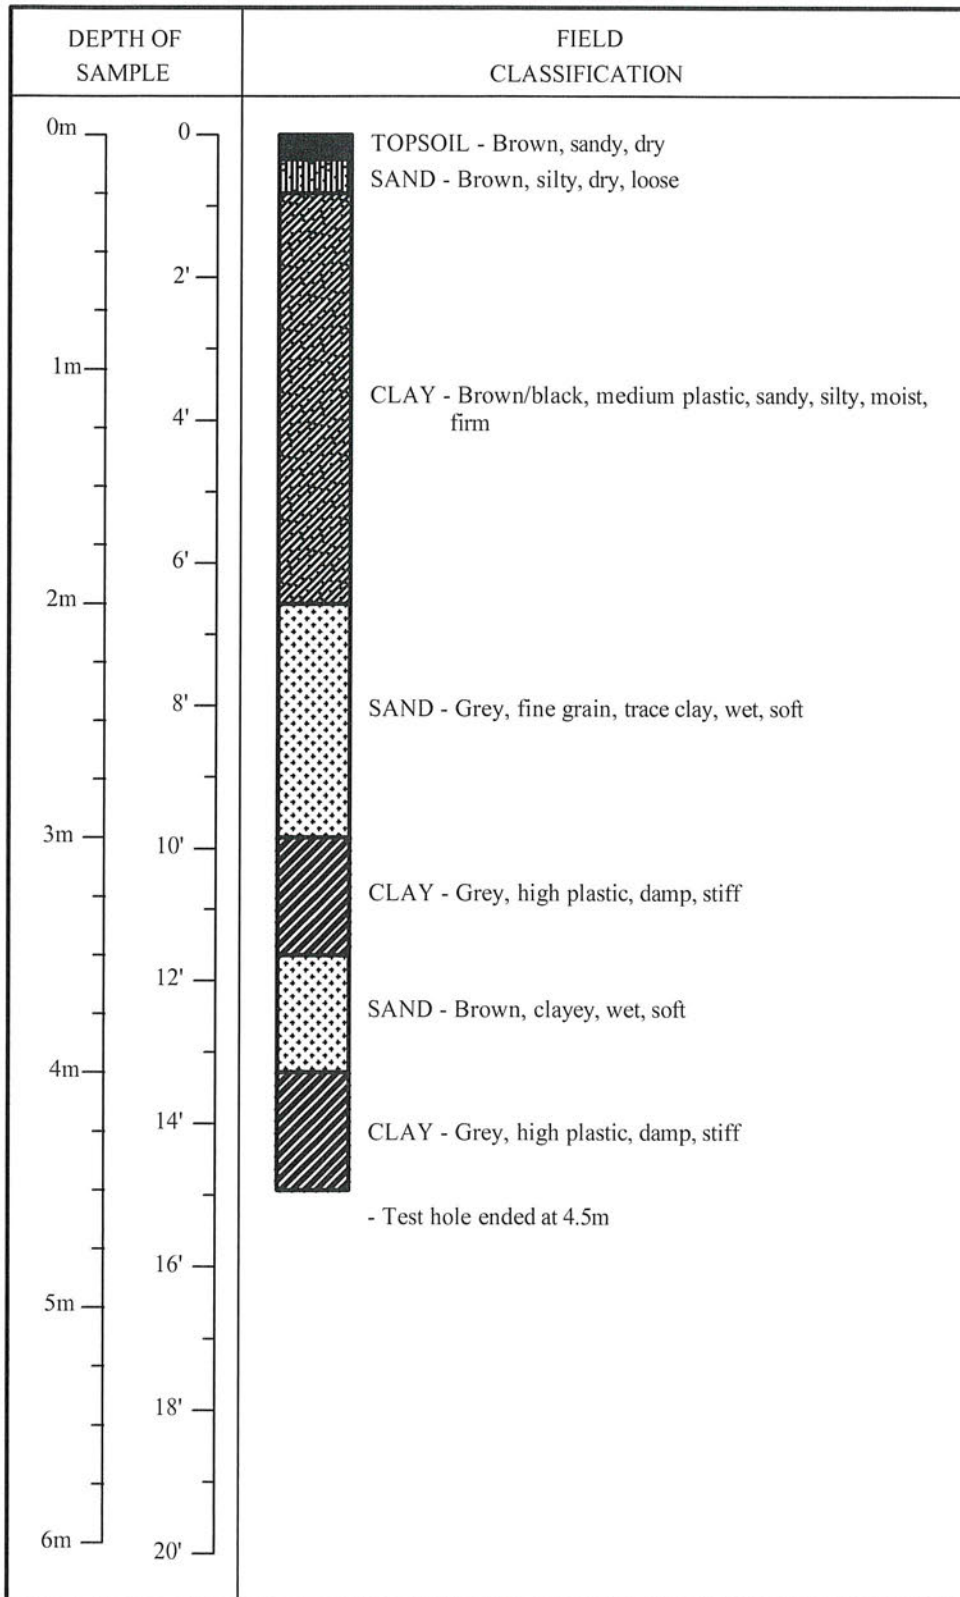
TEST HOLE # 1

The soil profile through the centre of the dike consisted of surficial sand, followed by a layer of medium plastic sandy clay to a depth of approximately 2.0 m below the top of dike. Underlying this is a layer of wet sand to a depth of approximately 3.0 m, followed by a layer of sandy clay. Groundwater was infiltrating through the sand layer at a depth of 2.0 m to 3.0 m below the top of dike.

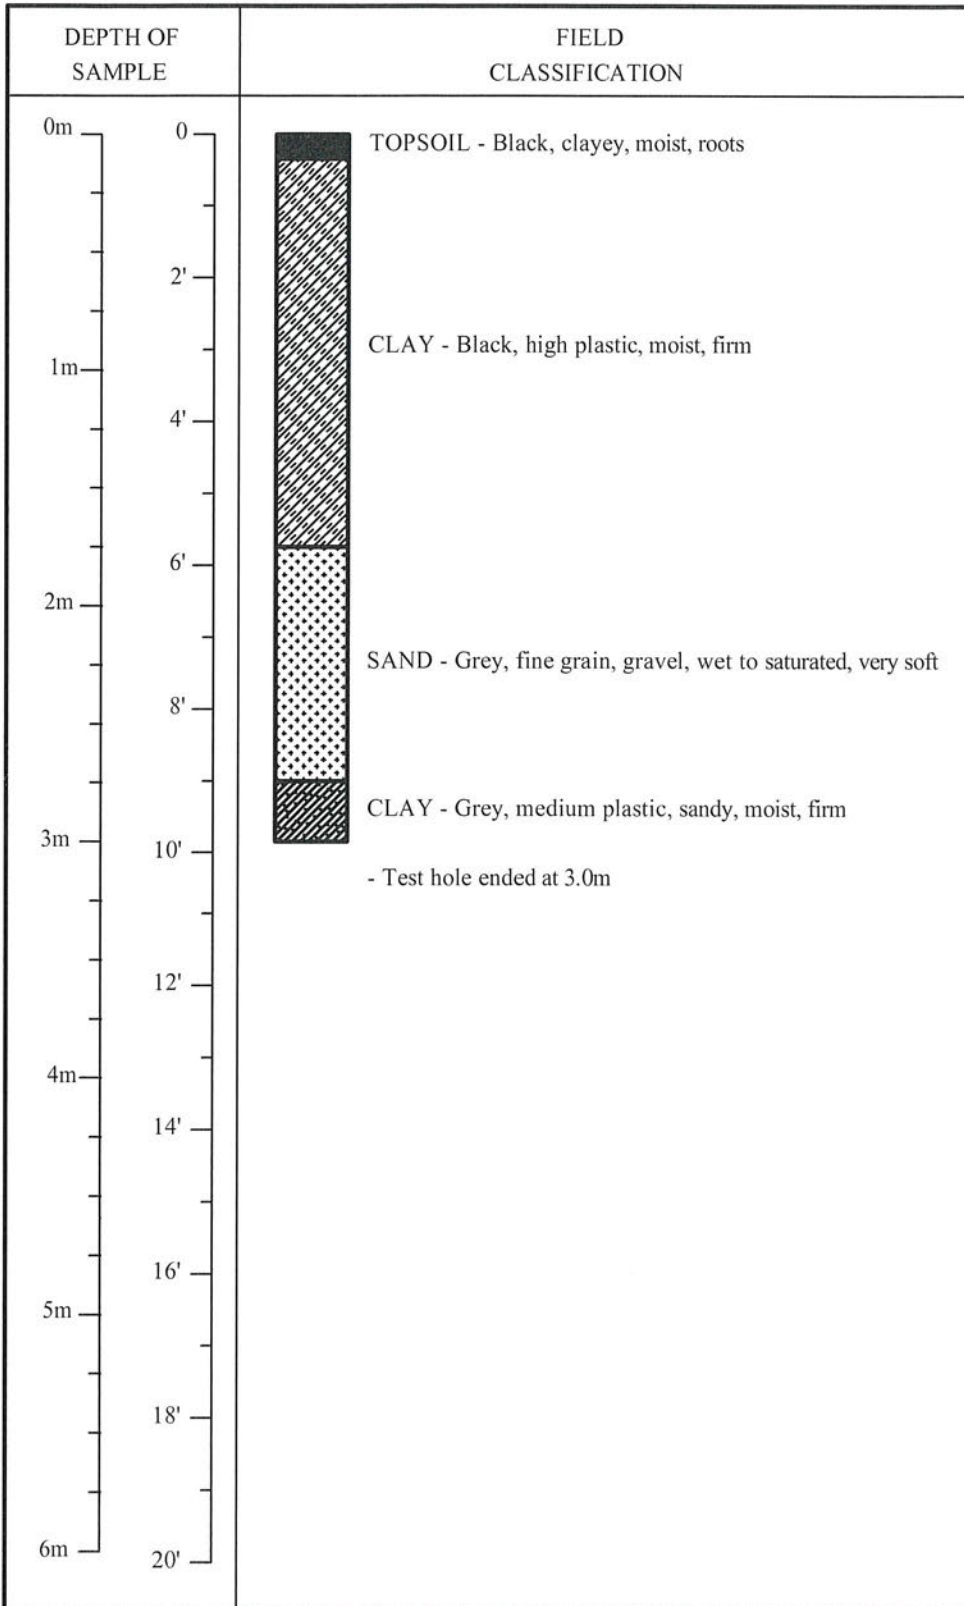
DATE : June 1, 2021  
 TEST HOLE # 3

The soil profile through the inner slope of the dike consisted of high plastic organic clay from the surface to a depth of 1.7 m, followed by a layer saturated sand and sandy clay. Groundwater was infiltrating through the sand layer at a depth of 1.7 m to 2.5 m below the surface.

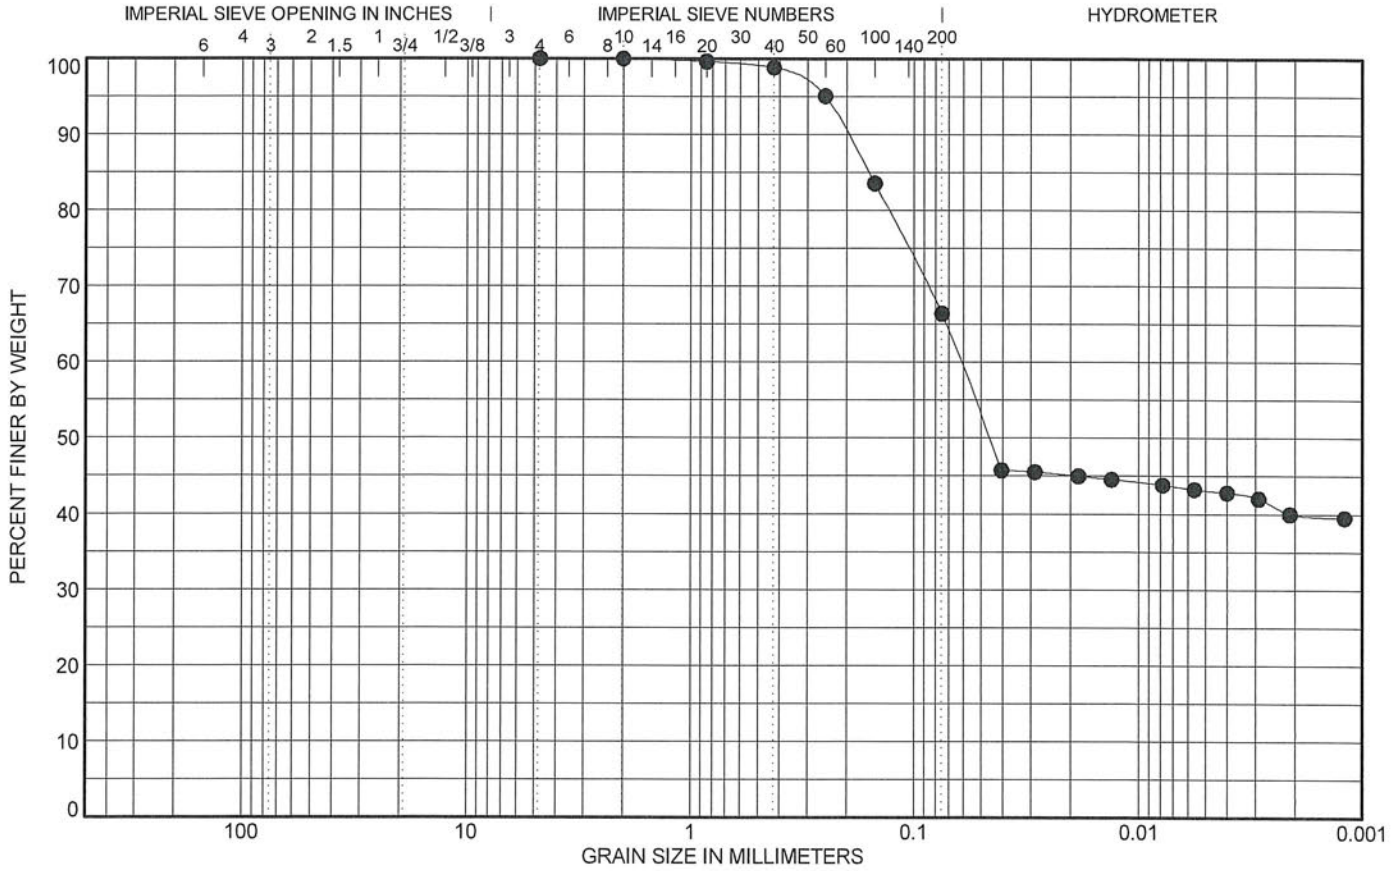
# PARTICLE SIZE ANALYSIS

The laboratory results indicated that the soil is a high plastic clay material and met the above requirements for cell liner suitability.

Sample ID	mUSCS	MC	D100	D60	D30	D10	LL	PL	% Gravel	% Sand	% Fines
● TH3 2021, 0.3 m	Cl	35.9	4.8	0.1			46	17	0	34	26 (Silt) : 40 (Clay)
