Water and Waste Department

**REPORT
ON THE
SHUTDOWN OF THE
NORTH END WATER POLLUTION
CONTROL CENTRE
ON
SEPTEMBER 16, 2002**

December 19, 2002

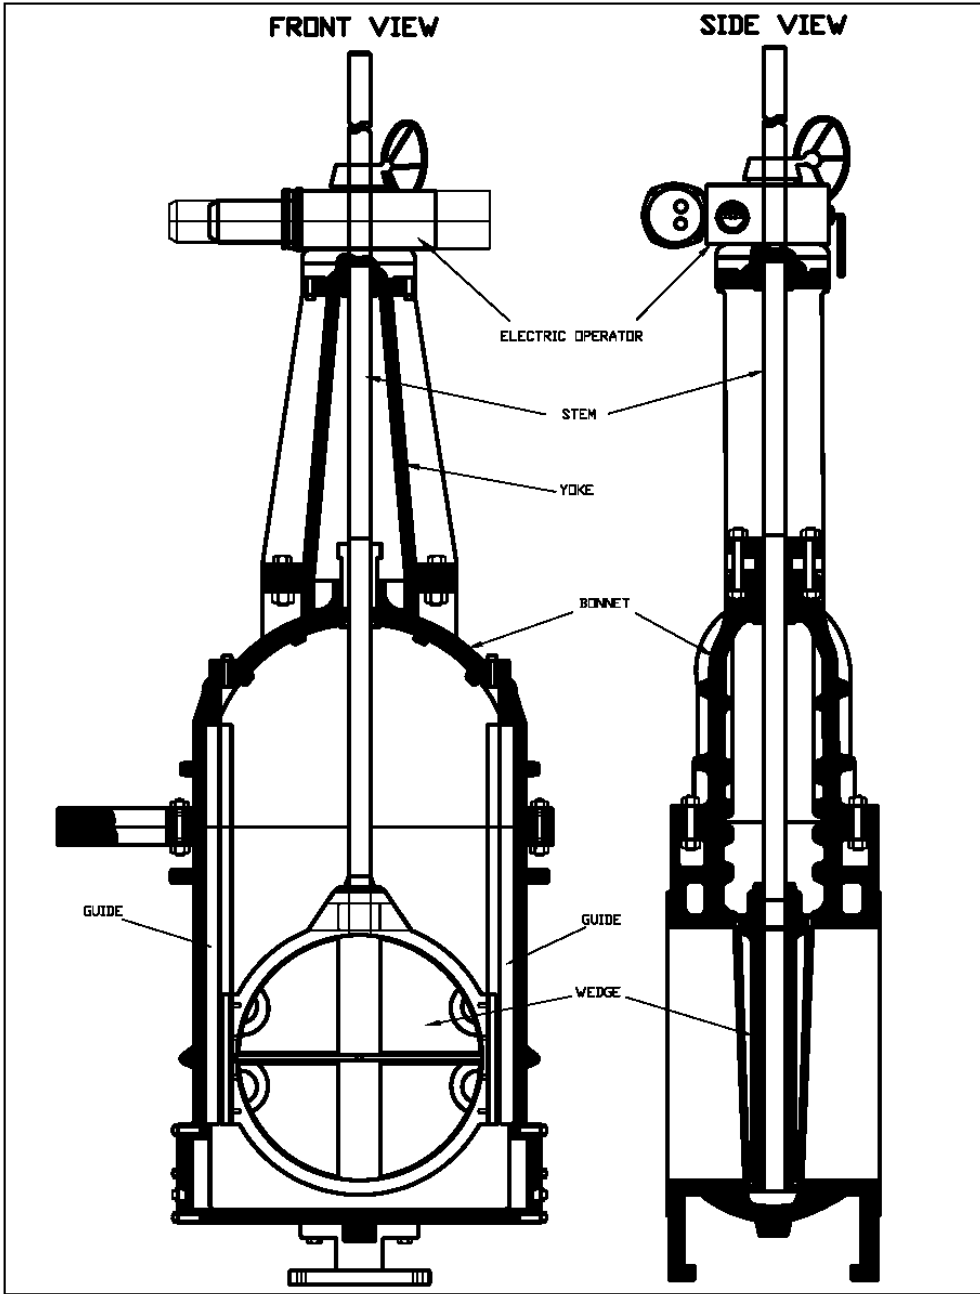
Figure 2.4 - Portion of Suction Valve Shop Drawing

- was ordered and manufactured in 1979 (the date 1979 is also cast into the valve).
- is approximately 30 inches thick (flange face to flange face), 50 inches wide and 145 inches high (closed) – according to shop drawings

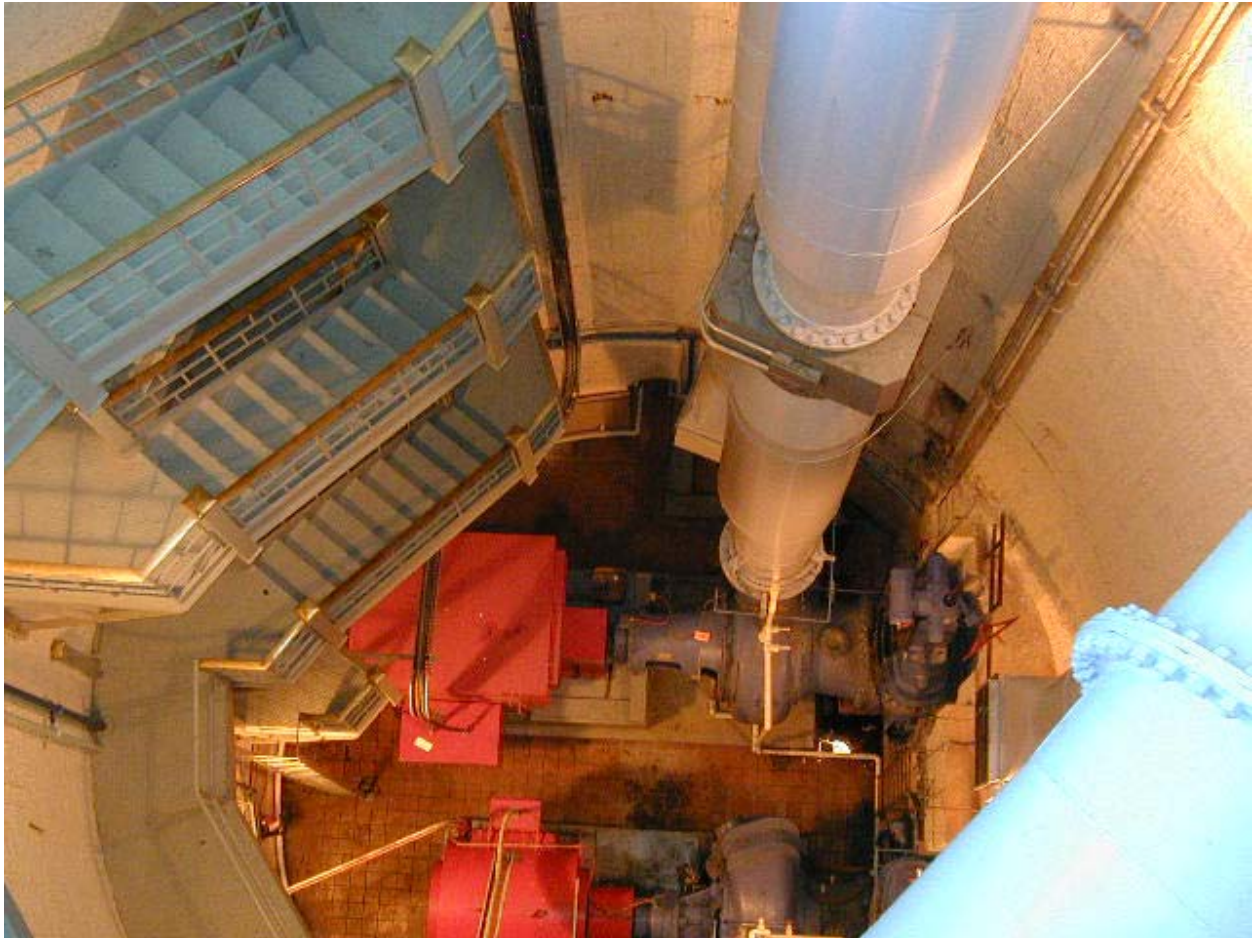
Figure 2.5 - Pump Well Number 1 - Looking Down at MP5. The suction valve is on the far right. The pump (MP5) is next to it. The motor is on the left (red).

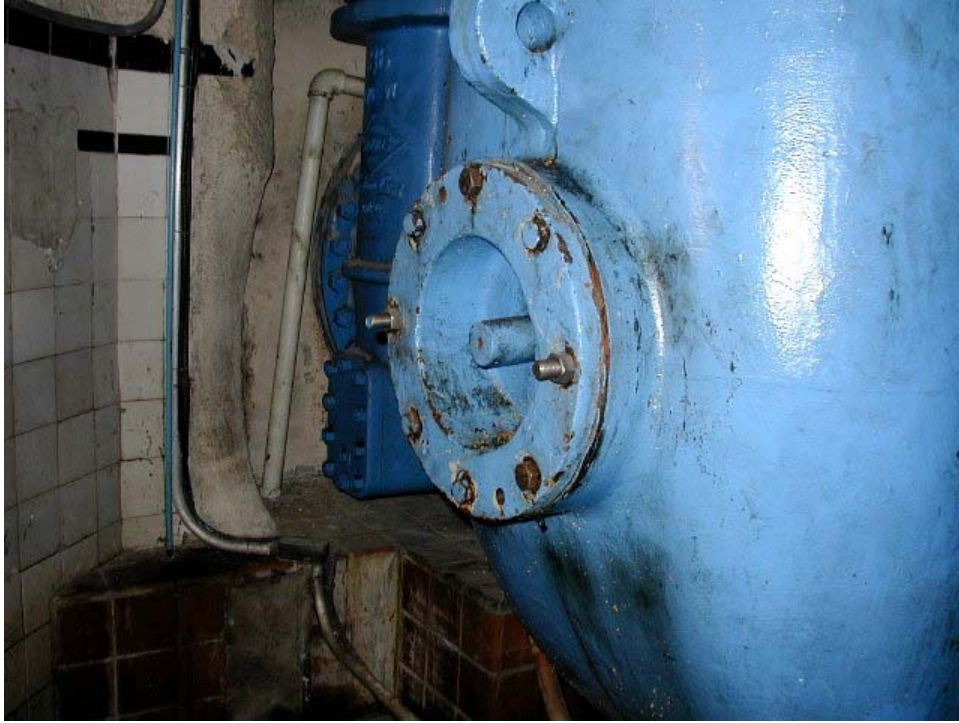
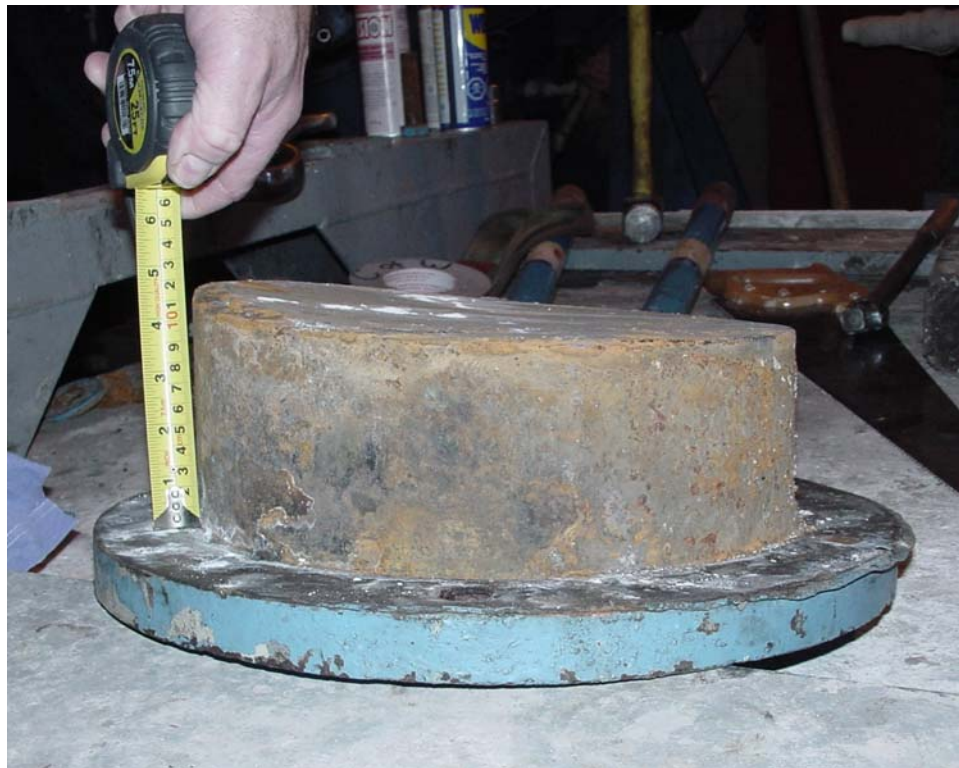
Fig. 3.1 - Views of the Inspection Plate after the event. The plate weights about 90 pounds.

- ii) After lunch, at about 1:10 p.m., Operator 3 went down the elevator first. The Lead Mechanic at the plant and the Apprentice Plumber were to follow. Operator 3 removed all but two side bolts in the inspection plate and moved it by hand. Then a little sewage flow came out. At that point, he decided that the flow had not stopped and that they would not be servicing MP5 on that day. He decided that the plate should be loosened a bit more to improve drainage and backed off the two bolts ½ turn. While he did this, the plate suddenly gave way.

- iv) The Lead Mechanic confirms that he came down the elevator after the Operator. He came around the motor, saw that the sewage was still leaking and then saw the plate come off and the sewage flow start. He ran to the valve and turned the handle with all his strength. Under these conditions, he managed to get another 7 or 8 turns (the equivalent of a wedge movement of 1/16th of an inch). The mechanic also thought that the flow would slow down, but it did not. Both men indicated that the sewage flow was a full 12-inch diameter horizontal jet that hit the wall of the pump well.

Like any accident, this incident was preventable. The staff themselves knew immediately how the procedure could have been modified to prevent catastrophic failure. For example, they could have installed longer bolts or studs on the inspection plate so that it could have been held in place and reinstalled. The operator called for longer bolts when it did happen. Staff have since installed longer bolts (studs) on two of the bolt holes on this inspection plate and plan to install similar studs on all of the inspection plates in this area.

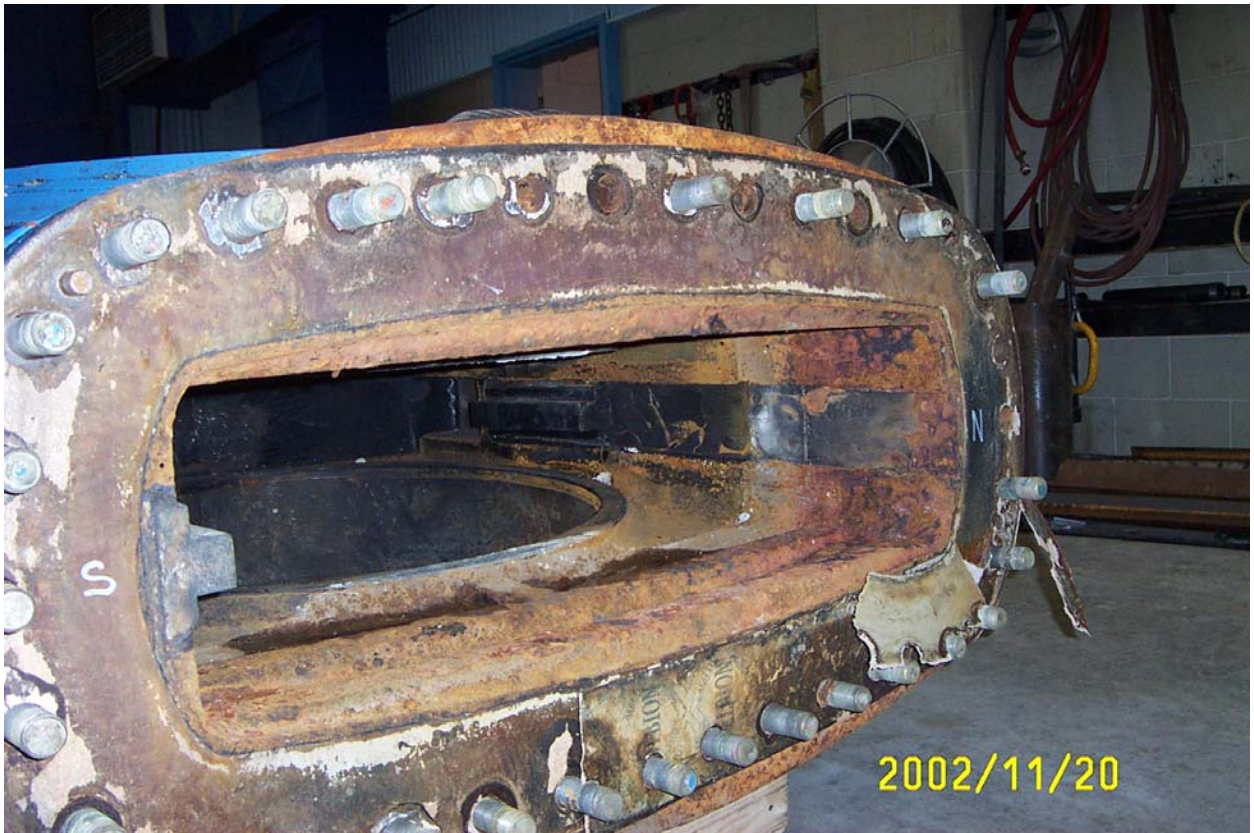
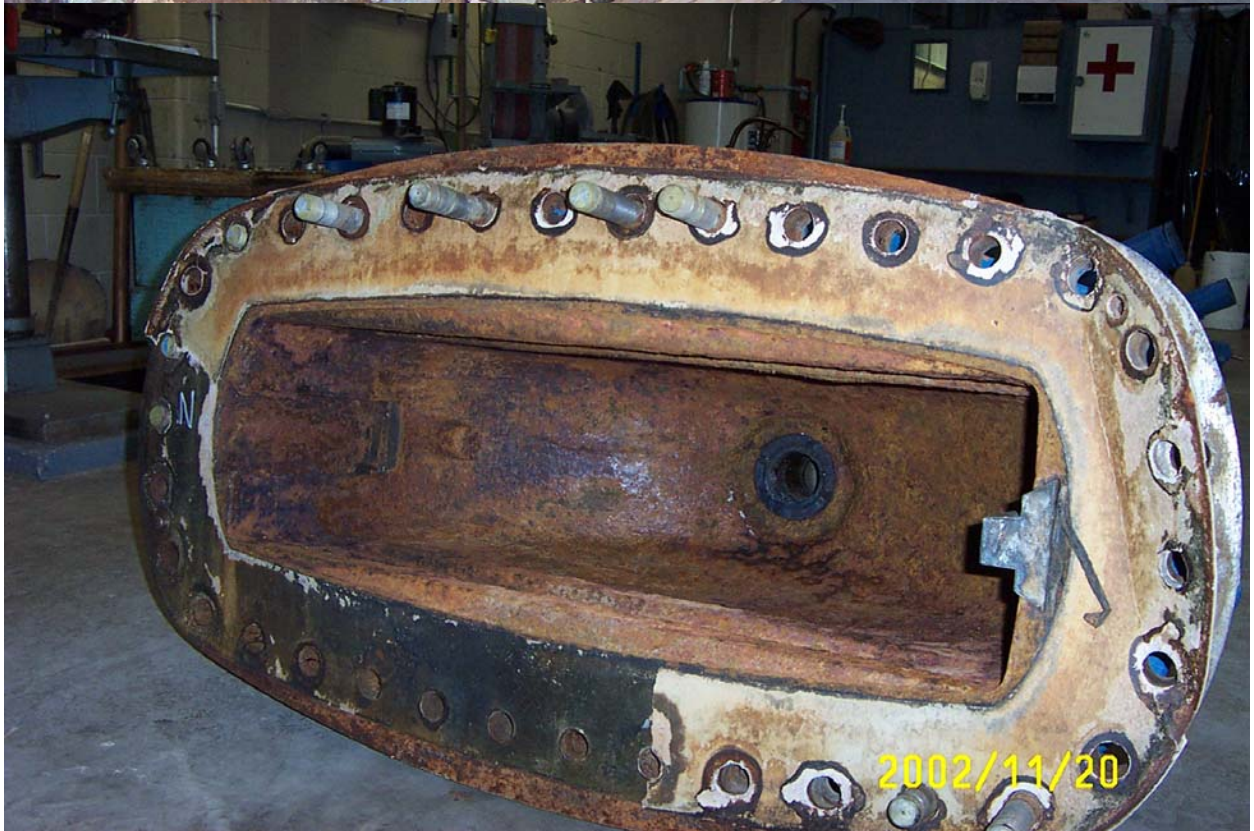
- The valve was open approximately 13.5 inches.
- On each side of the valve (north side and south side for reference) there is provision for a 42-inch guide dove-tailed and babitted into the valve body, and a 13.5-inch guide dove-tailed and babbitted into the valve bonnet.
- Only a 13.5-inch piece of the guide on the north side of the valve body was present; the other 42-inch guide was missing.
- The entire guide on the north side of the valve bonnet was missing.
- The 42-inch guide on the south side of the valve body was intact.
- The 13.5-inch guide on the south side of the valve bonnet was there, but was loose.
- The stem was pinned properly to the wedge.

- The 42-inch guide on the north side of the valve body was missing. To date, it has not been found. An inspection of the MP5 pump impellor reveals a large gouge, presumably from hitting and passing a substantial piece of metal, possibly the missing guide.
- The 13.5-inch guide from the north side valve bonnet ended up at the bottom of the guide channel in the valve body. Presumably, it was moved to this position as a result of opening and closing the valve.

- The valve wedge had lodged 13.5 inches open because the guide was missing on the north side. The valve wedge had offset and the guide on the wedge had contacted the 13.5 inch piece of the guide in the body, which then prevented the wedge from closing.
- The valve stem was intact. This meant that the earlier conclusion that the stem was in a position that the valve was closed was in fact in error. The stem on this valve would recess about 13 inches into the operator had the valve been closed. This is different than the other valves. The operators had used their experience on the other valves when they had determined the valve was closed. This valve, manufactured in 1979, has a valve stem approximately 14 inches shorter than the other similar valves manufactured in the 1960s.

Fig. 5.1 View of Valve Body (top) and Bonnet (bottom). Note missing guide on North side.

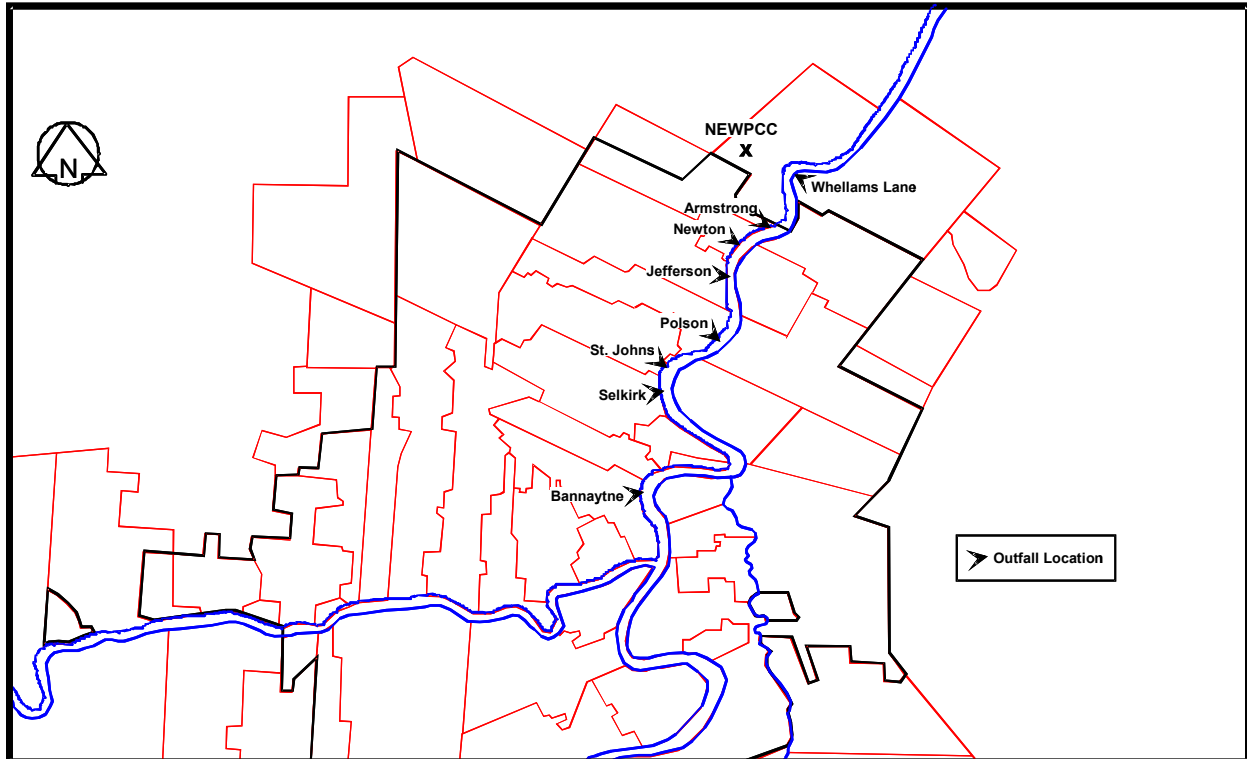
Figure 8.1: Overflow Locations

Based on containment efforts at outfalls and field observations noted by staff from the Laboratory Services Division, overflows also occurred at the Armstrong outfall and from the NE interceptor overflow at Whellams Lane. The interceptor system configuration, overflow weir elevations, the system alarms, and river levels, all verified that the Polson station was the first overflow location and the last to stop flowing. Figure 8.1 depicts the overflow locations.

Based on a detailed review of system records and conditions, approximately 427 ML (427,000 m³) of untreated wastewater was discharged to the Red River during the 57 hours the plant was shut down.

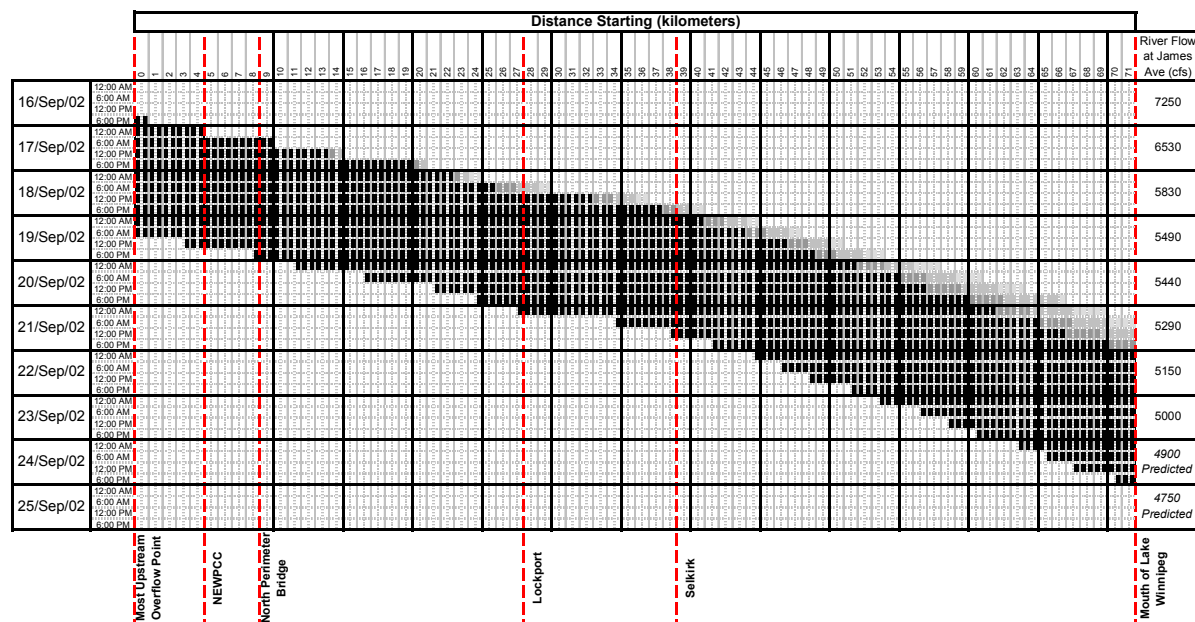
Figure 8-2: Estimated Travel of Untreated Discharge Down the Red River

- Reached Lockport at about 6 a.m. on September 18, 2002
- Reached Selkirk about 6 p.m. on September 18, 2002
- Reached Lake Winnipeg about 6 a.m. on September 21, 2002
- Cleared Lockport by 6 a.m. on September 21, 2002
- Cleared Selkirk by 6 p.m. on September 21, 2002
- Cleared the complete river system by midnight September 24, 2002

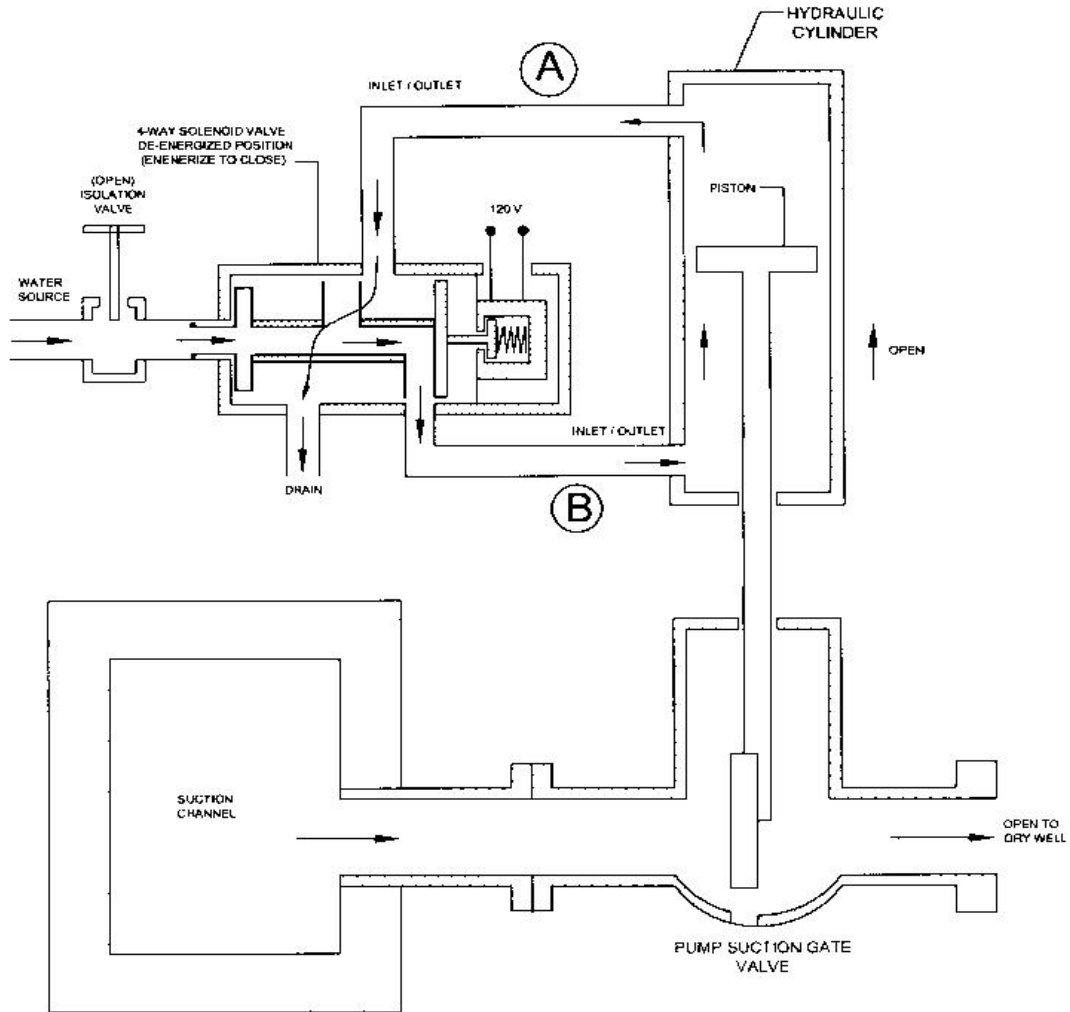
N.E.W.P.C.C. 1965 DRYWELL FLOODING
 SCHEMATIC – HYDRAULIC VALVE
 OPERATION

Document 2 indicates that any momentary power interruption will cause the solenoid valve to open the MP1 suction valve. While not documented, this may be because on loss of power, the relay in the emergency stop circuit would immediately release and de-energize the solenoid circuit. Resuming power would not re-energize the solenoid circuit and close the suction valve, unless the emergency stop button was pushed. Document 2 indicates that the electrical contractor tried to energize the solenoid valve by replacing the contactor, but does not indicate that the emergency stop button was pressed, which would have been required. In any case, it is likely that before the suction gate could close completely, the solenoid valve would have become immersed and shorted, which would have opened the suction valve again.

Note: In order to close the gate valve, divers closed the isolation valve, then cut the inlet/outlets at "A" and "B", and connected a water hose and fitting at "A", then turned on the hose water.

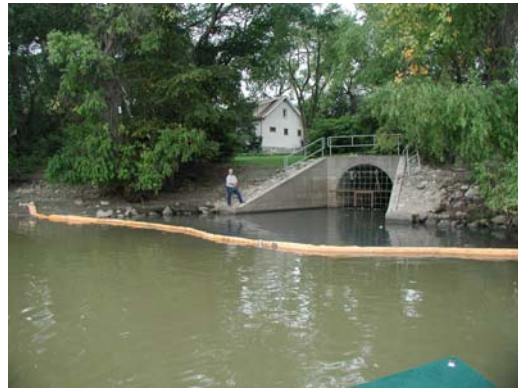
Boom Placed in the Red River to Catch Floating Debris at the Jefferson Outfall
