March 6, 2018

Subject: RM of Gimli – Emergency Request to Dispose of RM of Gimli WWTP SBR 2
Biosolids / Sludge Solids at RM of Gimli Waste Disposal Ground

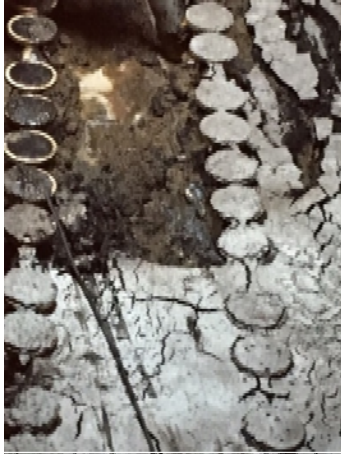
- In December 2017 the wastewater treatment plant aeration piping in SBR 1 failed.
- The RM started to receive odour complaints around this time due to the loss of half of the plant's treatment capacity.
- To inspect and fix the aeration issue, the RM of Gimli pumped out SBR 1 to SBR 2. Following pumping, significant solids were found below the diffuser level as shown in the below photo since the solids settled with no aeration.

- Following the cleaning of SBR 1, it was discovered that the SBR 1 aeration pipe supports corroded and failed. This led to the failure of several aeration pipes and the complete loss of aeration in SBR 1.

- The solids were slurried and removed by hydrovac truck and disposed of on top of the frozen emergency storage pond on site. It is likely that this disposal method resulted in increased odours from the site.

- The material to repair SBR 1 was ordered immediately and SBR 1 was put back into service on Feb. 28, 2018. All diffusers were also replaced during this repair period.
