**RE: KEYYASK GENERATION PROJECT – ALTERATION REQUEST,
REQUEST TO INSTALL A TEMPORARY CREEK CROSSING ON WINTER ROAD TO ELLIS ESKER
ENVIRONMENT ACT LICENCE NO. 3107, CLIENT FILE 5550.00**

Keeyask Generation Project
Temporary Creek Crossing on the Winter Road to the Ellis Esker
Description of Crossing – Winter 2018/2019 and Winter 2019/2020

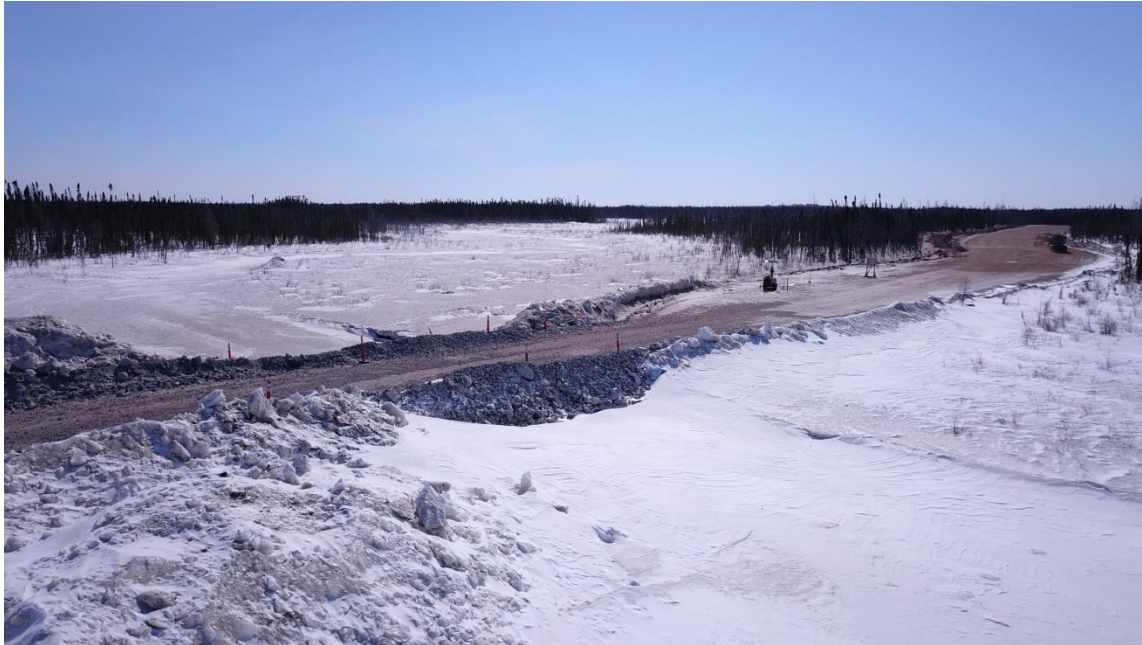
Photo 1. Temporary creek crossing on winter road to Ellis Esker, April 7, 2018

A temporary rockfill crossing was constructed February 15-16, 2018. The crossing utilized four (4) 750mm steel culverts, 14 m long installed on top of rig mats. See Photo 1 for a picture of the completed crossing. A summary of activities and monitoring that occurred during construction can be found in Appendix 1, this information was included in the Environmental Protection Plan Annual Report (<https://keeyask.com/wp-content/uploads/2018/06/EnvPP-2018-01-Environmental-Protection-Plan-Annual-Report.pdf>).

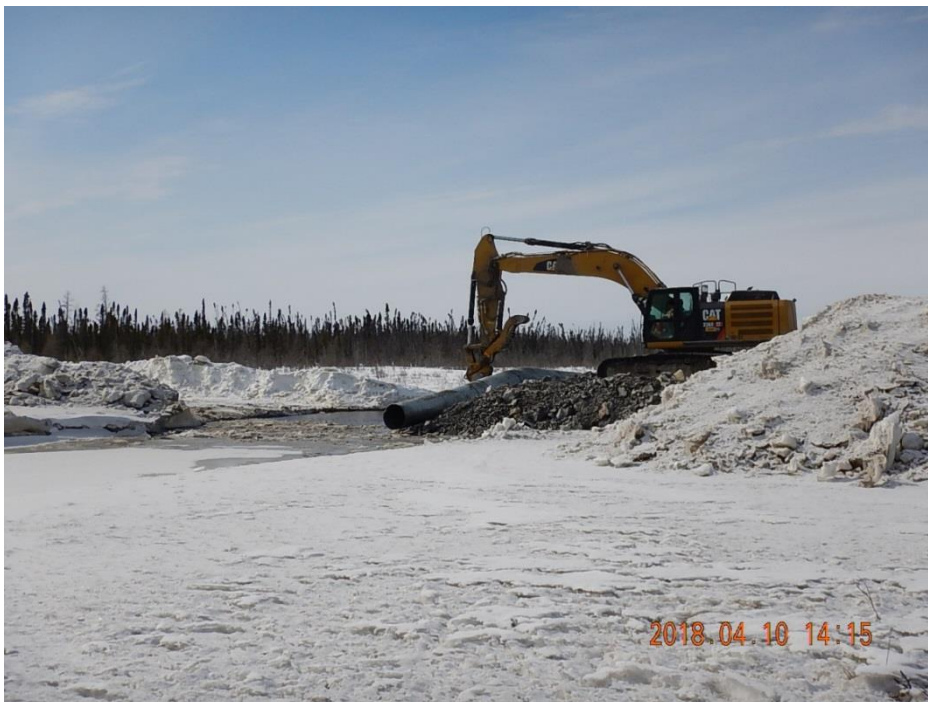
Photo 2. Removal of temporary creek crossing on winter road to Ellis Esker, April 10, 2018

The crossing was removed April 10 -11, 2018, refer to Appendix 2 for a summary of activities associated with the removal of the crossing. See Photo 2 for a picture of removal of the crossing and Photo 3 for a picture of the creek once the crossing was removed. Photo 4 and 5 are pictures of the creek taken in August 2018.

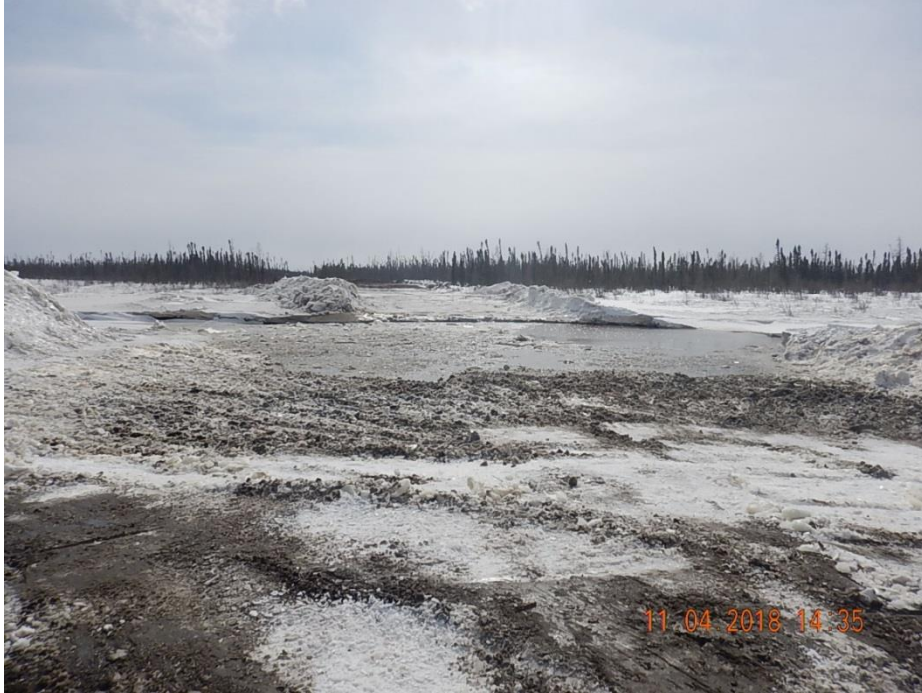
Photo 3. Creek after temporary crossing removed, April 11, 2018.

A temporary rock crossing was installed in February 2018 and removed in April 2018, all mitigation measures stated and recommended were implemented, Photos 3 and 4 show the condition of the water body in August 2018. Based on past experience of the construction and removal methods as described above, adverse environmental effects to install a temporary rockfill crossing for the 2018/2019 winter season and potentially the 2019/2020 winter season are not expected.

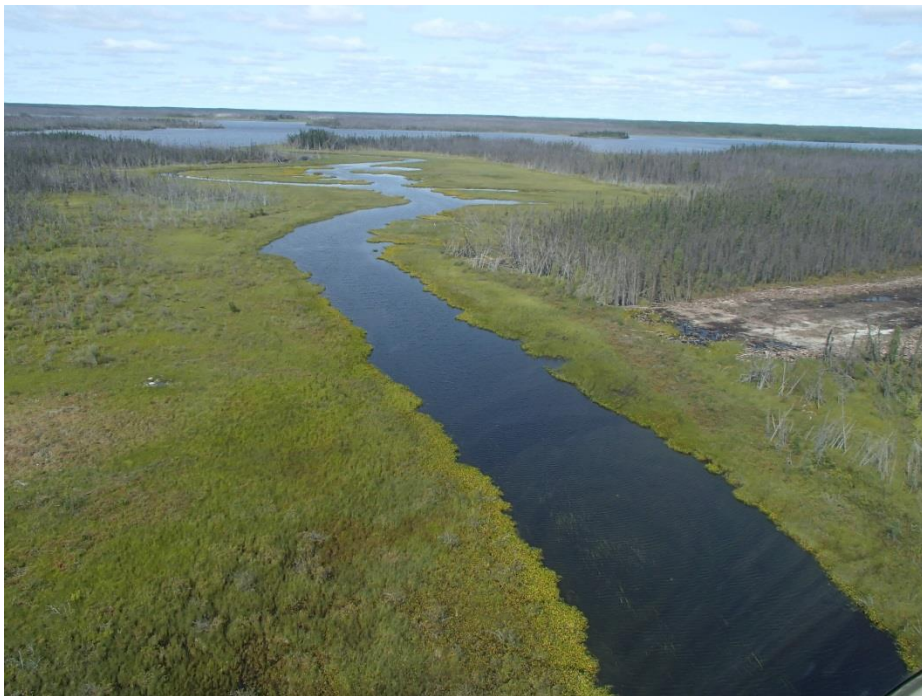
Photo 4. Creek crossing along the winter road to the Ellis Esker with Joslin Lake in the background, August 25, 2018.

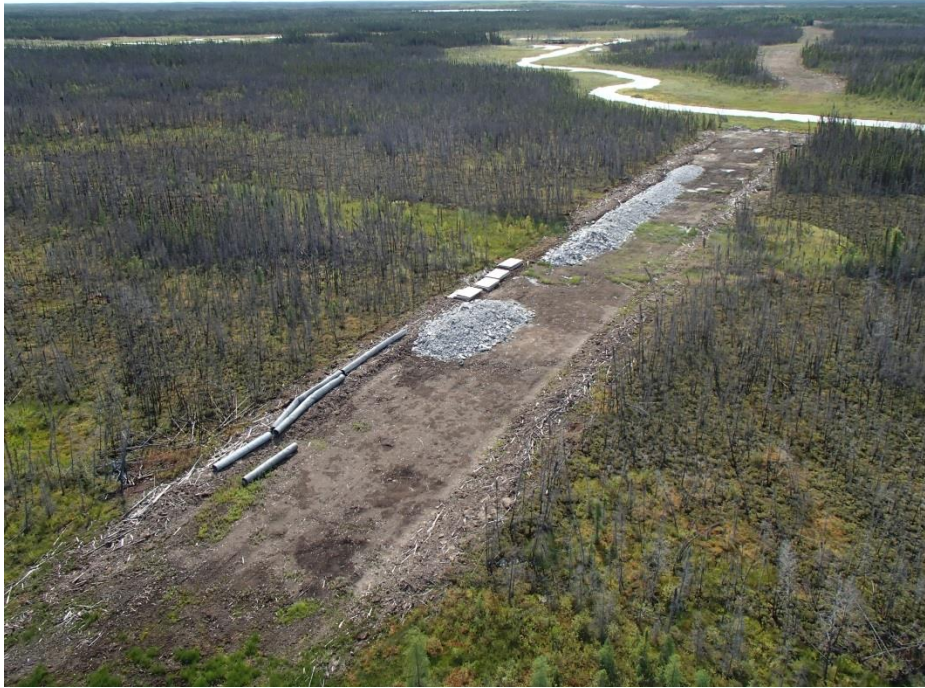
Photo 4. Material stored along winter road to the Ellis Esker, August 25, 2018.

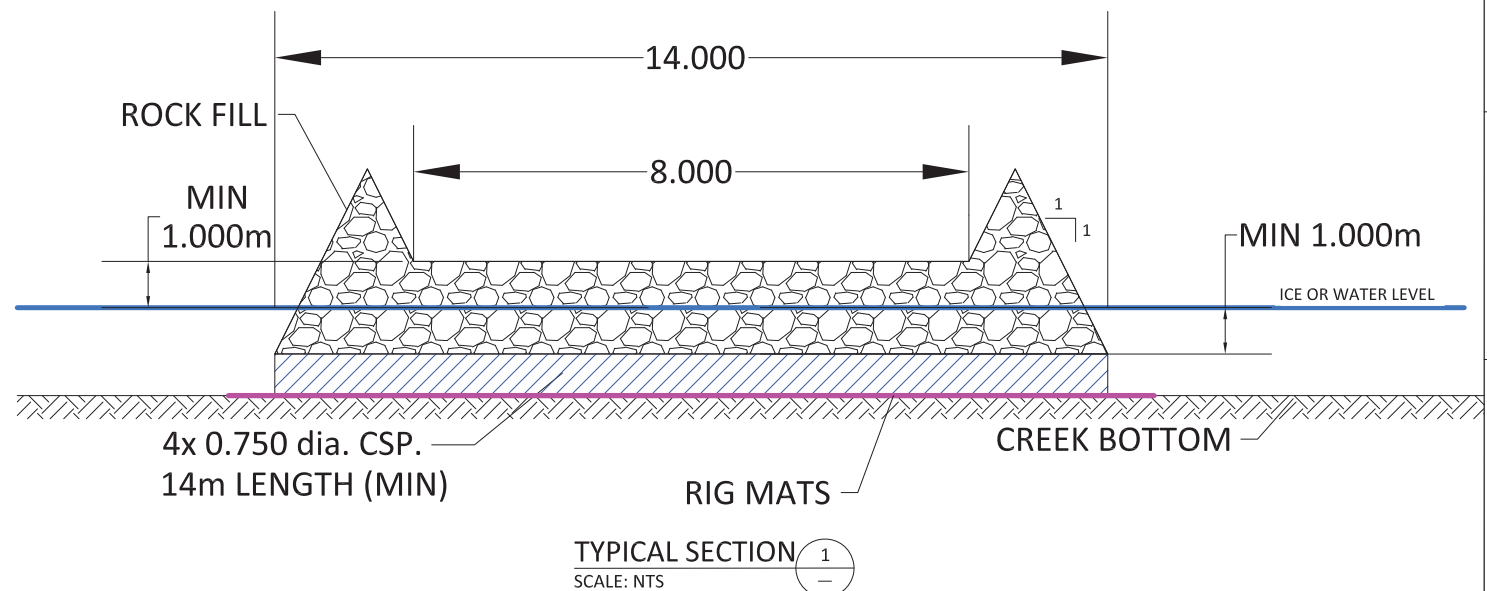
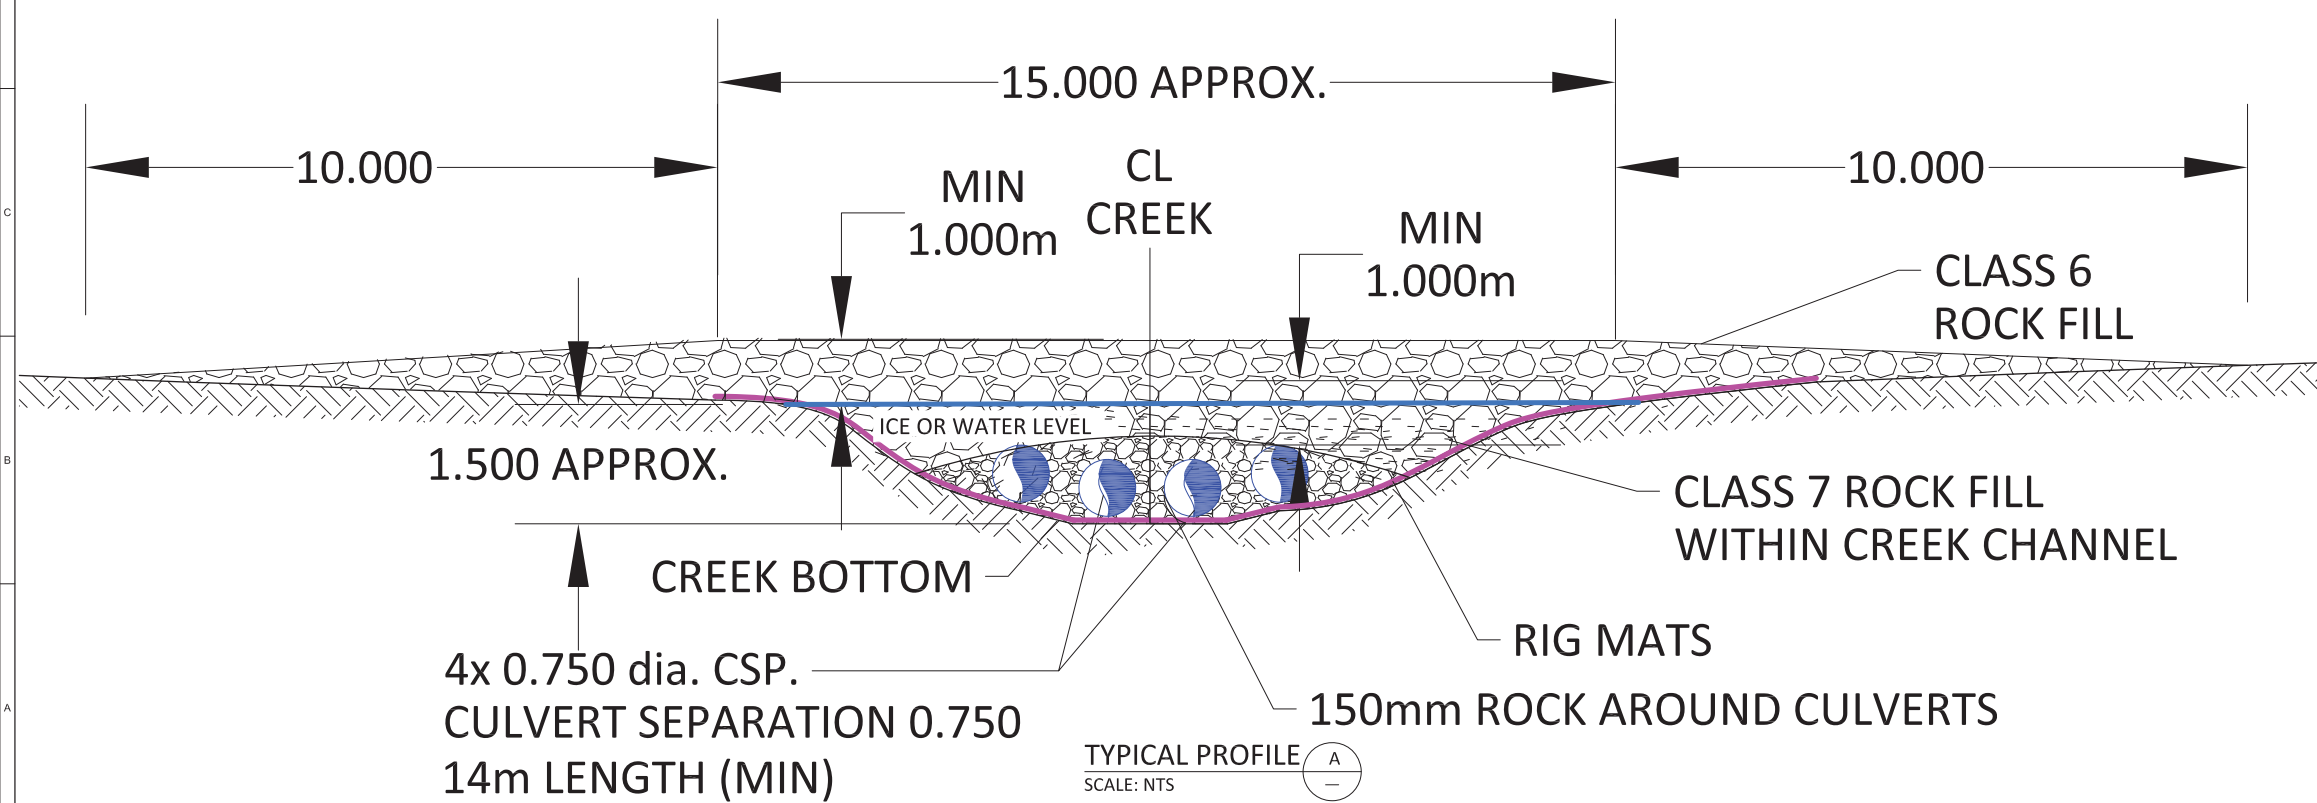
REV.	DATE	DESCRIPTION	CHECKED:	BY	CRD.	APP.
DRAWN:		CHECKED:		SCALE: AS NOTED		
DESIGNED:		DATE: February 10, 2018				
KEYYASK GENERATION PROJECT						
CREEK CROSSING DETAILS						
DRAWING NUMBER				SHEET		REVISION
KS-364				01		00

- NOTE:
- Crossing installed winter 2018.
 - Crossing installed and removed in the wet.

The proposed crossing will again utilize four (4) 750mm steel culverts, 14 m long. Prior to the placement of any material, rig mats will be placed on the bottom of the creek. Refer to Figure 2 for details of the temporary rockfill crossing. The crossing will be installed once access to the site is available which is anticipated to be by mid-December or early January when access along the winter road is established. The temporary crossing will be removed prior to April 15 of the following year. The footprint of the rockfill crossing is approximately 240 m².

1. Construction of rockfill crossing will occur in the wet – duration is approximately 3 days
 - a. Place rig mats on the bottom of creek bottom.
 - i. Equipment: Loader and excavator
 - b. Place layer of rockfill on top of rig mats. Start construction on the north shore and advance to the south shore.
 - i. Equipment: Excavator or dozer to advance rockfill onto rig mats.
 - c. Install culverts
 - i. Equipment: Excavator to place the culverts on the rig mats

- d. Place rockfill around the culverts, continue to advance the rockfill to the south shore
 - i. Equipment: Excavator to place rockfill around the culverts and excavator or dozer to place rockfill to the south shore.
- e. Continue with additional lifts of rockfill to achieve desired crest elevation.
 - i. Equipment: Excavator or dozer to complete additional lifts.
- 2. Removal of rockfill crossing (prior to April 15) – duration is approximately 2 days
 - a. Remove rockfill, culverts and rig mats.
 - i. Equipment: Excavator to remove the rockfill and culverts and loader to assist with piling and loading out of the materials into a truck.

To limit sedimentation from installation and removal, a coarser class 7 rockfill will be utilized. For structural support of the culverts a clean 150mm rock material will be utilized around the culverts and above the water line a class 6 rockfill. Fines and impervious material will not be used. See Table 1 for gradations of class 6 and class 7 rockfill.
