Reference: Daly Irrigation Project – 2013 Final Monitoring Report – Licence No. 3010

Stantec Consulting Ltd. (Stantec) submits the following 2013 Final Monitoring Report for the Daly Irrigation Project, on behalf of the Daly Irrigation Development Group (DIDG; the Licencee). This letter provides a summary and status of monitoring data collected in 2013, as required by *Environment Act* Licence No. 3010 (the Licence), issued on July 5, 2012.

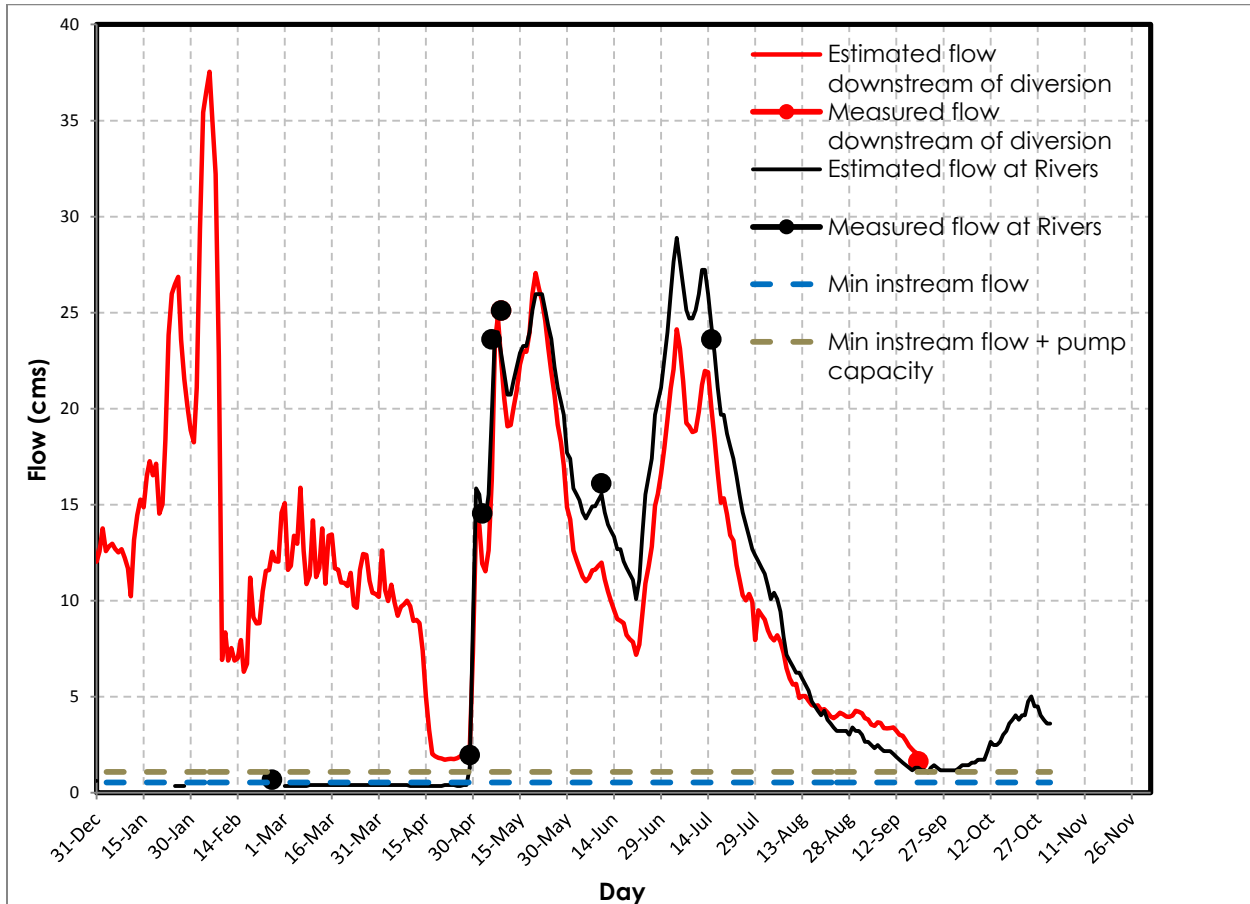
Figure 1 - Daily Average Streamflow Upstream and Downstream from Diversion

For purposes of this report, flow rates upstream and downstream of the diversion point were compared during the irrigation season from July 3 to September 19, 2013. The Water Survey of Canada website was used to retrieve measured flows at the upstream gauging station (05F018). Figure 1 shows estimated flow rates (m³/sec) recorded daily at the upstream (black) and downstream (red) monitoring stations in 2013.

At the beginning of Spring 2013, the two estimated stream flows show similar patterns and upstream-downstream correlation. During the irrigation season, downstream flow was generally lower than upstream, indicating withdrawals at the diversion. Towards the end of the irrigation season we see flow rates higher downstream of the diversion point than upstream, suggesting localized flows between the two stations.

The estimated flow downstream of the diversion was above the minimum instream flow requirement of 0.524 m³/sec throughout the 2013 recording period required by the Licence. These flow rates exceed the minimum instream flow requirement in the Little Saskatchewan River (0.524 m³/sec) and minimum instream flow rate plus the maximum allowable pumping rate (0.524 m³/sec + 0.555 m³/sec = 1.079 m³/sec). This suggests that operation of the Daly Irrigation Project did not cause the flow immediately downstream of the diversion point to drop below the minimum instream flow in 2013. The minimum flow rate recorded downstream of the diversion point in 2013 occurred on the final day of irrigation on September 19 at 2.03 m³/sec. The upstream recorded

flow rate shows a similar drop in flow rate near the end of the irrigation season, suggesting that seasonal conditions contributed to the reduction of these flow rates.

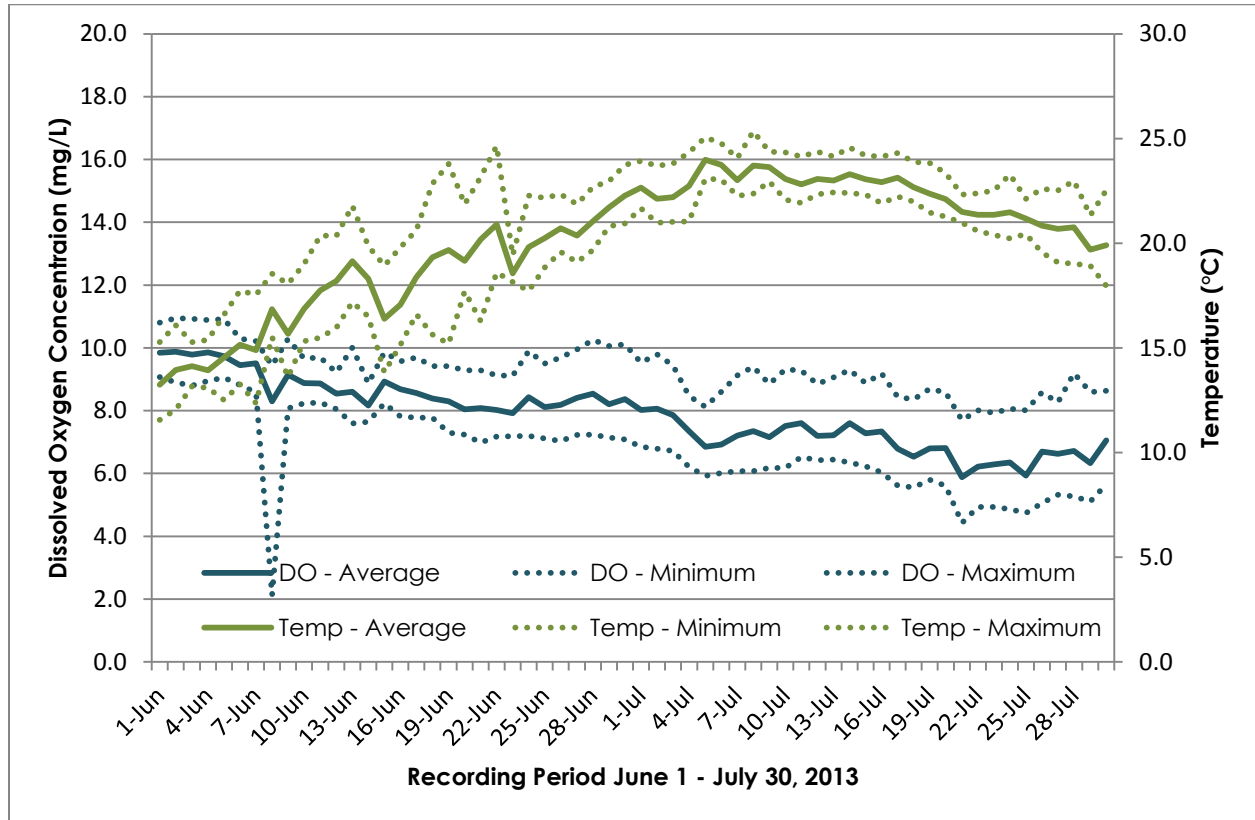
Figure 2: Dissolved Oxygen Concentration, June 1 – July 30, 2013

The DO logger was deployed on May 7, 2013 and recorded DO and temperature values on an hourly basis until July 31, 2013. Daily average, minimum and maximum DO concentration and temperature were recorded and are summarized in Figure 2.

Following the beginning of the 2013 irrigation season on July 3, average daily DO concentration has been between approximately 5-10 mg/L. Daily minimum values fall slightly below 5 during the latter part of July. Levels have not dropped below the 2 mg/L required for fish survival during recording dates. The lowest DO concentration reported in Figure 2 was 2.1 mg/L on June 8, prior to commencement of the irrigation season. The overall daily average DO concentration during the recording period was 7.9 mg/L.

DO concentration data for the period of July 31, 2013 to September 19, 2013 was not recorded due to equipment malfunction. Methods to prevent future equipment malfunction are discussed under Monitoring Activities Planned for 2014.

Additional equipment checks along with re-calibration should be made to retrieve DO concentration data consistently and avoid possible malfunctions.

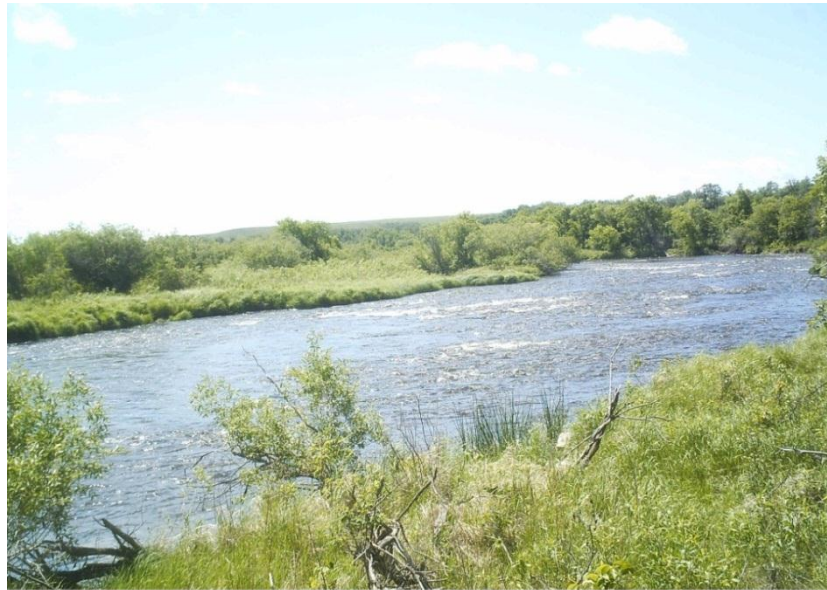
Photo 1: July 7, 2013 Pumping Active

Appendix B includes photographs which show the riffle during active irrigation dates on July 7, July 29, and August 13, 2013. Photographs in Appendix B which show the riffle on non-active irrigation dates include July 5, July 30, and August 30, 2013. A complete set of photographs taken by the trail camera are included on CD-ROM (enclosed).

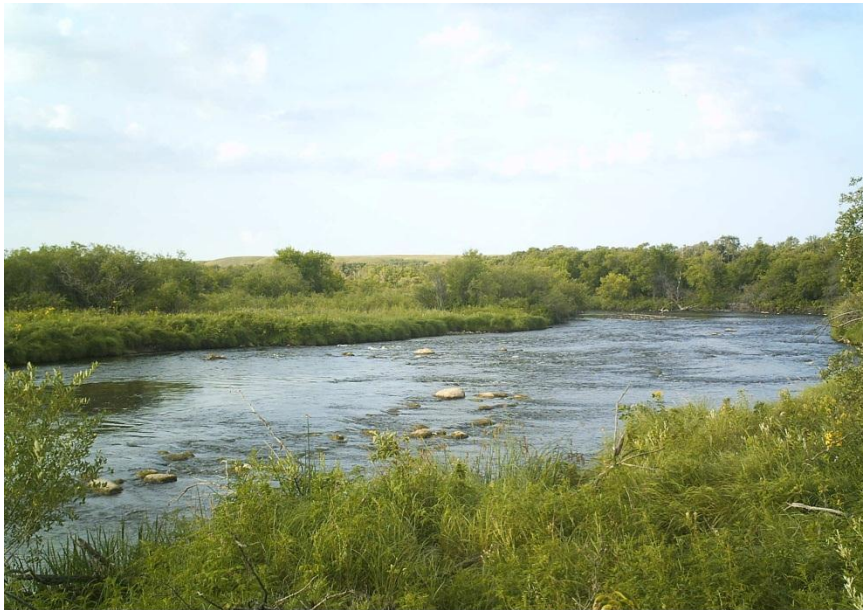
Photo 5: August 13, 2013 Pumping Active

Photographs were not recorded between August 13, 2013 and September 19, 2013 due to equipment malfunction. Methods to prevent future equipment malfunction are discussed under Monitoring Activities Planned for 2014.

The trail camera which is positioned to record photographs of the riffle during active and non-active irrigation dates should be inspected periodically. Electronic files should be downloaded from the camera on a frequent basis to avoid data loss.

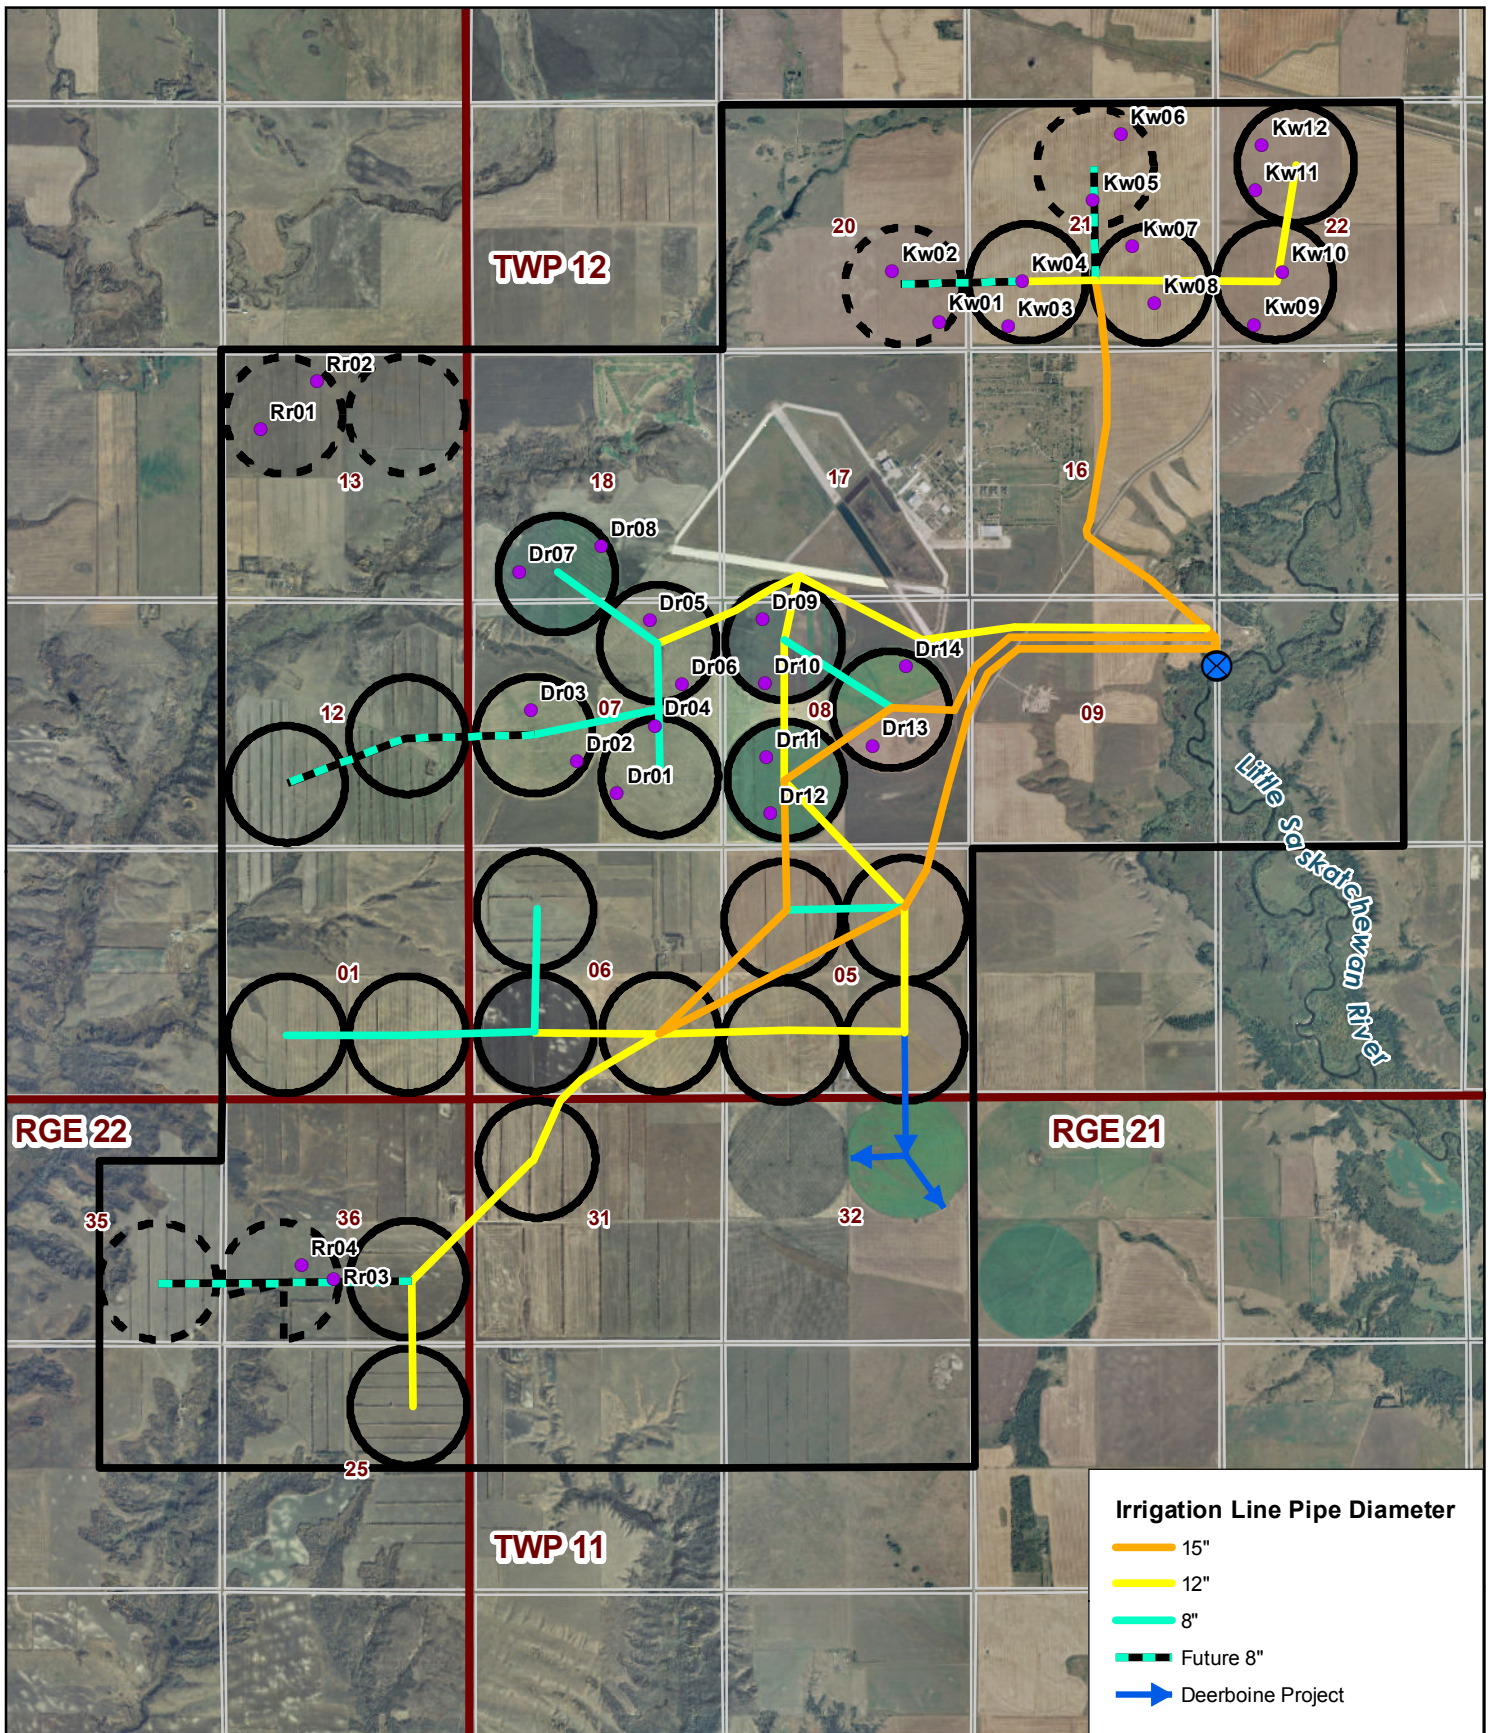
Several irrigation components, including pivots and irrigation lines, which were proposed in the DIDG Environmental Impact Assessment (Stantec, 2012) were constructed in 2013. Figure 3 in Appendix C shows an updated Project Footprint of these components. Future construction of proposed pivots and irrigation lines are being considered for construction by DIDG in 2014 to provide additional irrigation service to more fields.
