Keeyask Transmission Project **Environmental Effects Monitoring Plan** Annual Report

Prepared by:
Manitoba Hydro
Winnipeg, Manitoba
June 2017

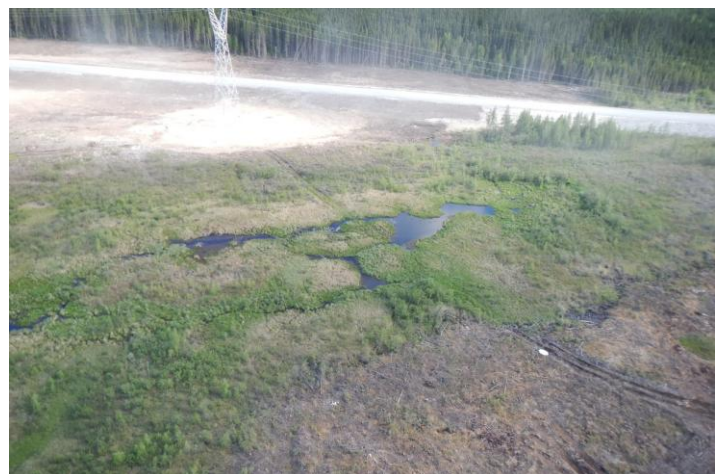
Photo 4: Evidence of minor damage due to vehicle traffic across a stream crossing.

As predicted in the EA, Project effects on stream crossings were minor. Of the 41 watercourse sites assessed in 2106, construction at all but one stream crossings was compliant with prescribed mitigation. This site (Photo 4) showed evidence of minor damage to due to vehicle traffic.

Plan was effective. Sites identified in 2015 as being non-compliant with the prescribed mitigation showed signs of successful natural revegetation, with no further remediation warranted.

Due to the natural revegetation of damaged locations, no further remediation is required.

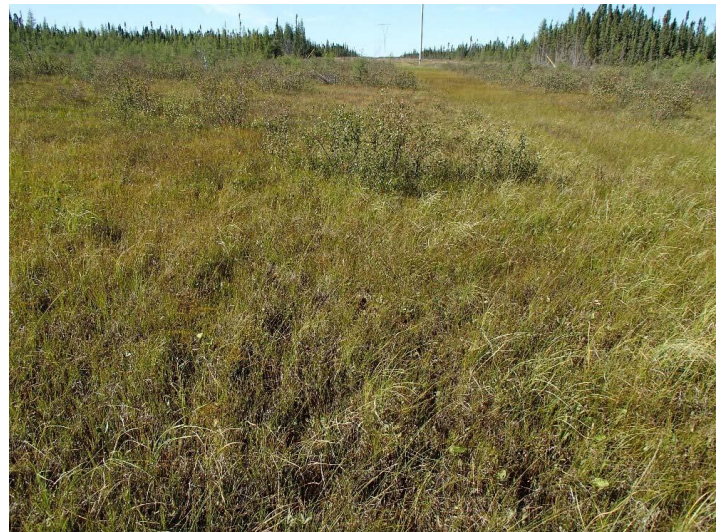
Photo 8: Horizontal fen supporting a large patch of muskeg lousewort within the ROW.

As predicted in the EA, Project construction had very low effects on the four known priority plant locations in the Project area. Muskeg lousewort (*Pedicularis macrodonta*) is the only rare plant known to occur in the Project area. Healthy, living muskeg lousewort plants were found at all four priority plant locations, post construction.

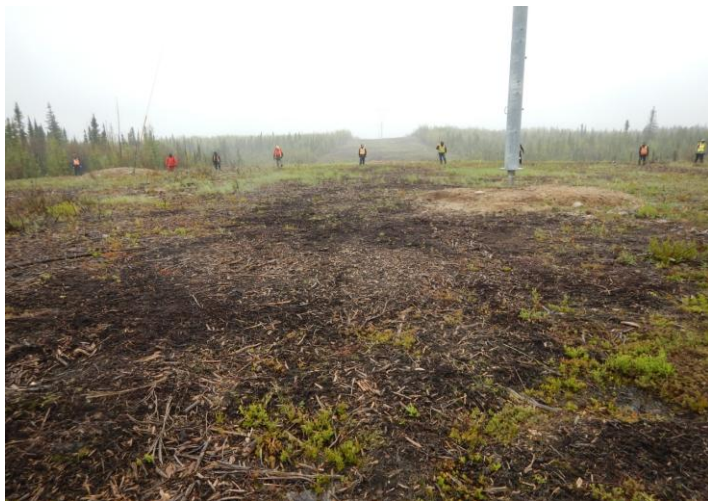
Photo 10: Survey personnel searching for bird-wire collisions at environmentally sensitive sites.

As predicted in the EA, the installation of power line sentry and spiral bird diverters on the Keeyask transmission lines at environmentally sensitive sites appears to have been successful at protecting birds from collisions. After correcting for searcher efficiency, scavenger removal bias, and habitat bias, minimum estimated collision mortality was 10.80 birds/km in the late breeding bird season and 10.32 birds/km in the fall migration period. These bird-wire collision mortality estimates are lower than rates reported in the literature.
