Lake Winnipeg East System Improvement Transmission Project

2017 Vegetation Biophysical Monitoring Report

Prepared for:
Manitoba Hydro
360 Portage Avenue
Winnipeg, MB

Project No. 1595 | February 2018

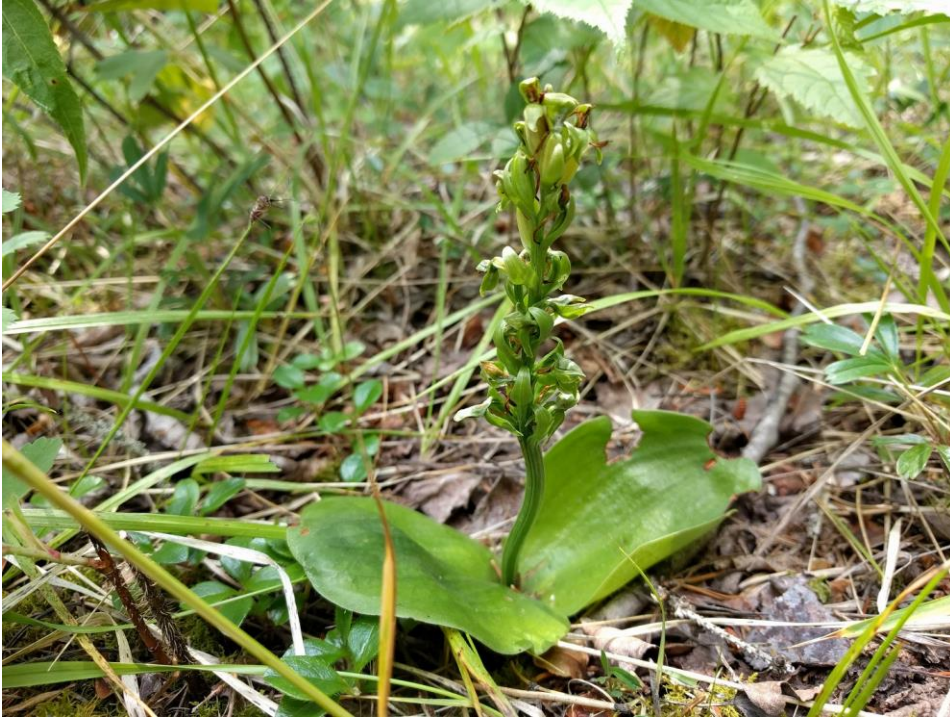
IMG_20170718_143209 – Hooker's Orchid (*Platanthera hookeri*) at LWE-Eco-302 on July 18, 2017.

The 2017 survey of the known Hooker's Orchid population (LWE-Eco-302) documented a total of 10 plants (11 had been observed in 2016). In general, conditions have

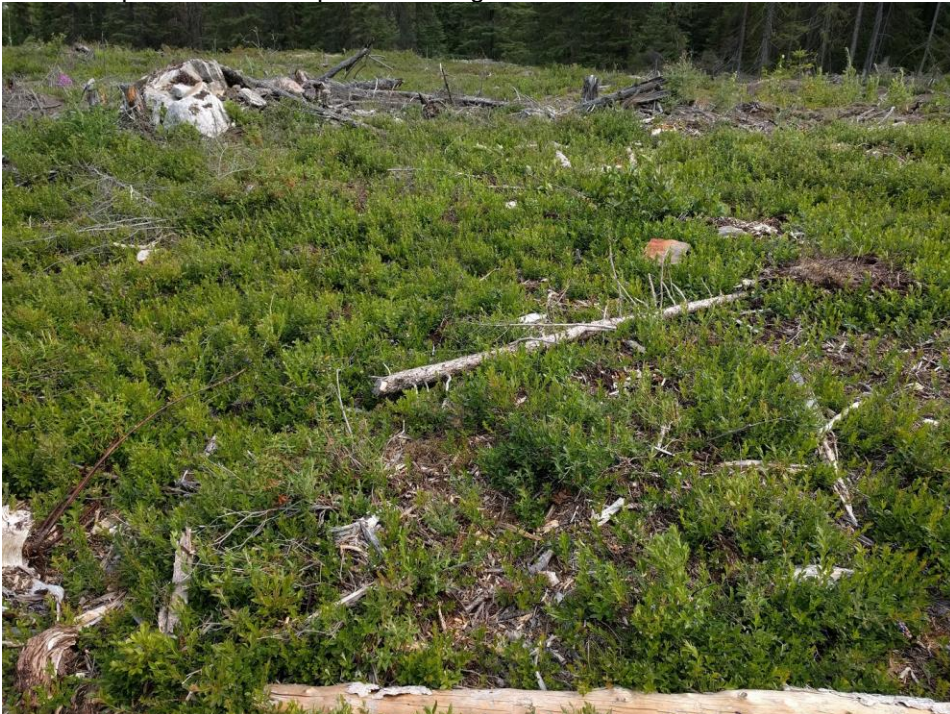
IMG_20170719_103244 – Healthy, dense stand of Low Sweet Blueberry (*Vaccinium angustifolium*) within the transmission corridor at a sample plot. Blueberry coverage was 85% within the plot with 75% of plants bearing fruit.

Surveys conducted in 2016 and 2017 indicate that plant species gathered by Indigenous People for food or medicine appear to have responded well to the clearing along the RoW. Blueberry is the most abundant gathering plant which was identified and both Low Sweet Blueberry and Velvet-leaf Blueberry are present in large swaths with many patches bearing abundant fruits at the time of the July surveys. As noted in the 2016 annual report, Blueberry prefers rocky outcrops and shallow soils and these areas generally lacked abundant tree cover and thus the accumulation of mulch at these sites is not a concern.

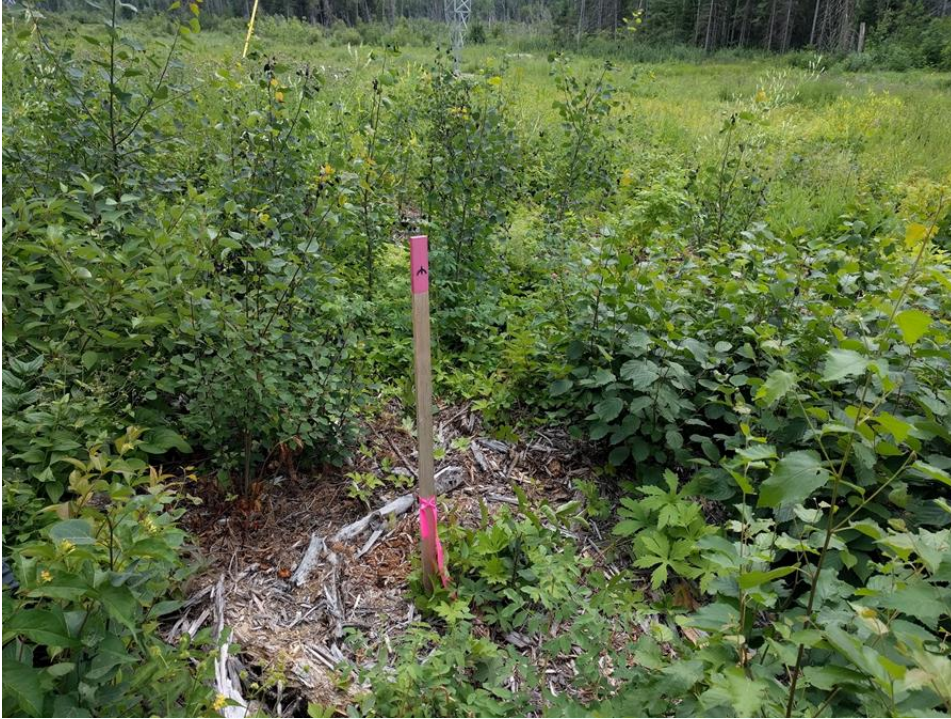
IMG_20170718_144814 – Moderate re-growth of trees and shrubs within the transmission corridor. A large proportion of upland areas which were treed prior to vegetation clearing had reverted to this type of vegetation cover by the July 2017 surveys.

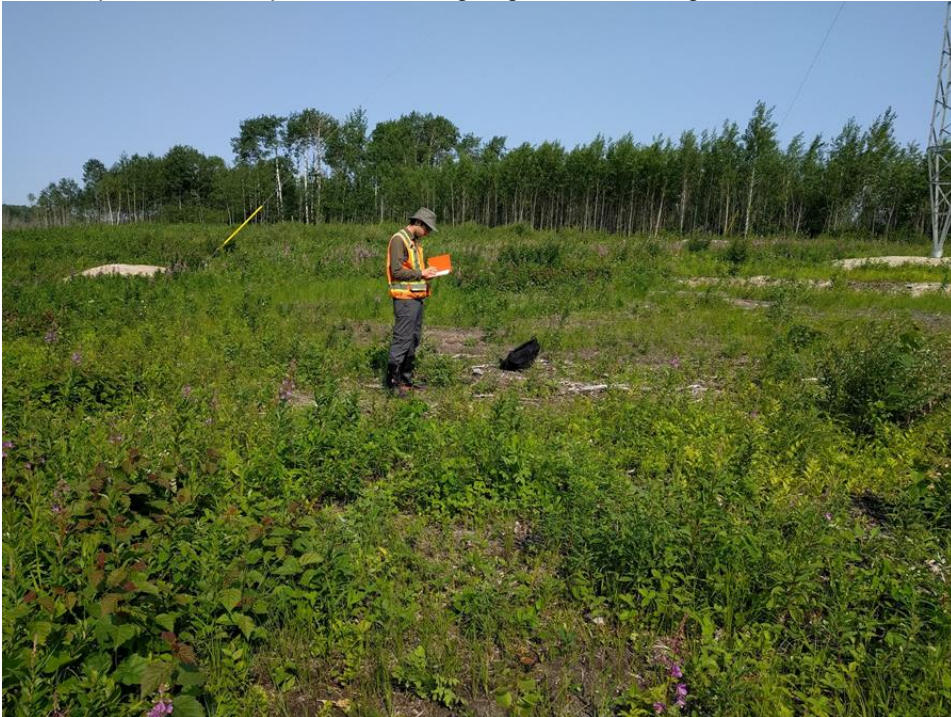
IMG_20170718_102519 – Re-growth of herbaceous and woody vegetation through areas which had deep wood mulch present following vegetation clearing in 2015/2016.

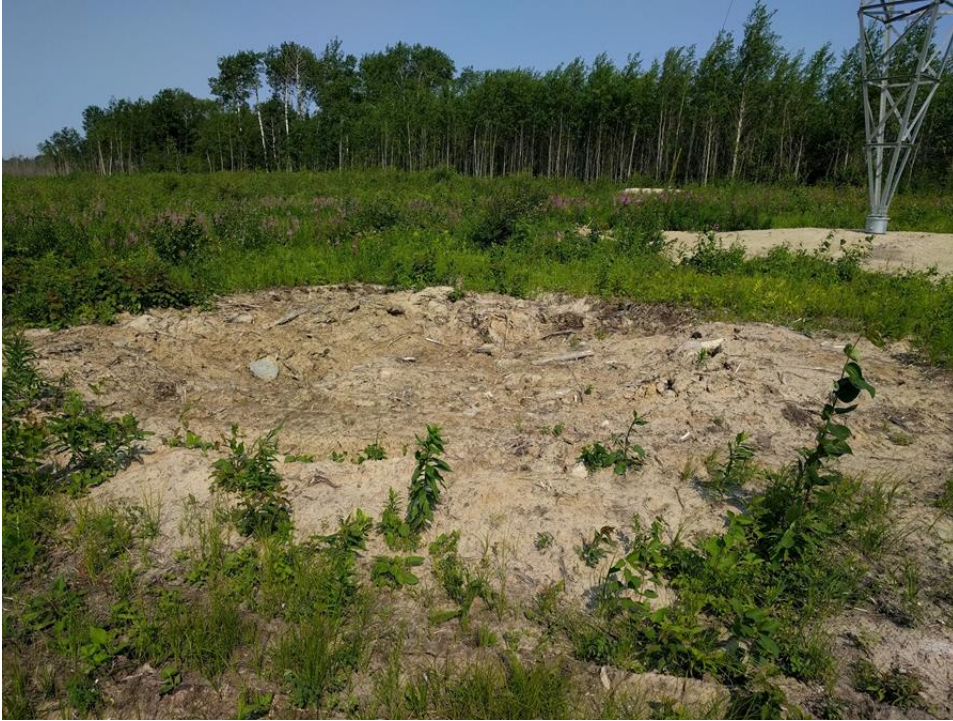
IMG_20170718_103234 – Small areas of disturbance at tower locations appearing slow to revegetate but generally free of non-native, invasive species.

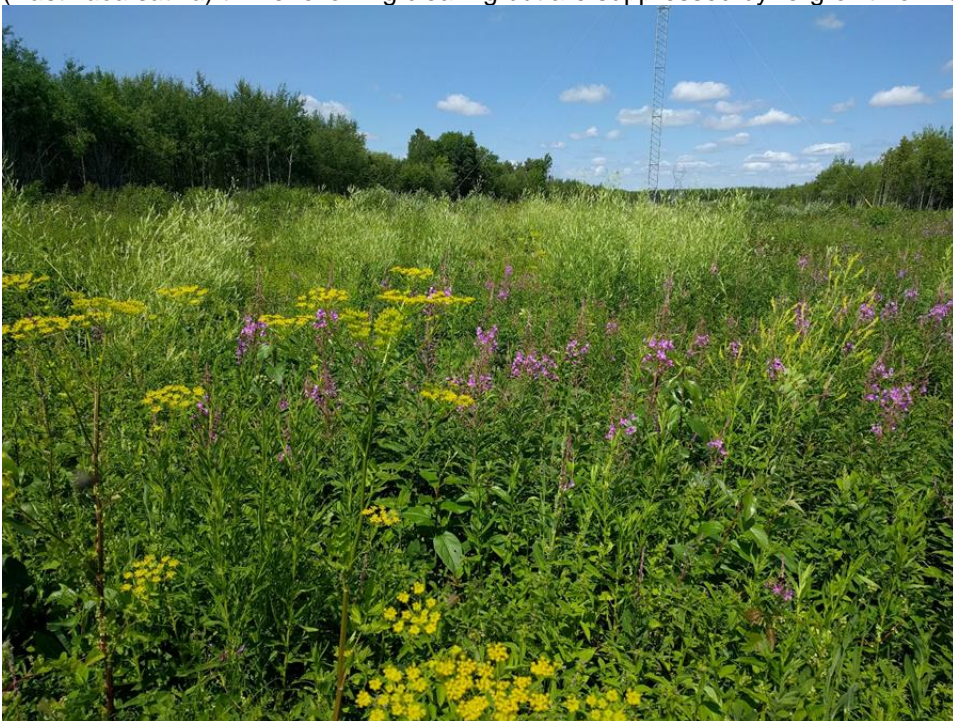
IMG_20170719_145639 – Patches of non-native, invasive species occur sporadically within the RoW (LWE-Eco-304). Species such as White Sweet Clover (*Melilotus alba*) and Wild Parsnip (*Pastinaca sativa*) thrive following clearing but are suppressed by re-growth of woody species.

Of those species listed above, surveys in 2017 found White Sweet Clover, Canada Thistle and to a lesser extent Yellow Sweet Clover and Wild Parsnip, to be the most widespread and aggressive species within the RoW. The remaining species are very localized and typically not prone to outcompeting native vegetation. It was noted that invasive species are not establishing within wetland or rock outcrop areas within the RoW and most species show a preference for upland habitats with mesic soil conditions.

As mentioned in the 2016 report, these species will thrive in the short-term due to the reduced woody species competition. The re-growth of a dense shrub layer will continually suppress and limit their spread within the project area. It is noted that although these species are aggressive in disturbed habitats, none are prone to establishing and proliferating within the adjacent forest, swamp, bog and marsh habitats.

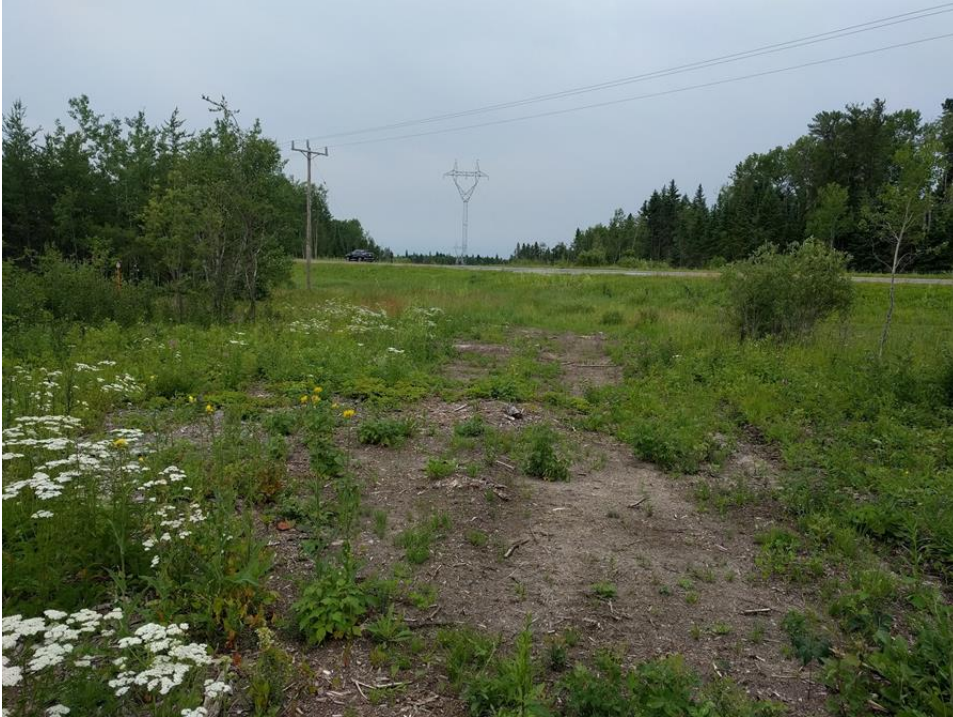
IMG_20170721_121324 – Open sight line down transmission corridor from Provincial Road #304.

During the 2017 surveys, Manitoba Hydro staff requested that all locations where the transmission line crosses Provincial Road #304 be assessed for potential mitigation to enhance vegetation cover and reduce sight lines down the transmission line from the road. This activity was intended to identify a strategy to increase vegetation cover at road crossing locations to provide cover to wildlife, namely Moose (*Alces alces*), which can be easily spotted within the recently grubbed RoW under the current conditions. The RoW crosses Provincial Road #304 at 4 locations, the southern-most being near pine falls at Broadlands Road. At the 3 crossing locations to the north, the road elevation is typically 1-2m above the grade of the adjacent RoW. As a result, enhancing

The following recommendations should be considered as means to reduce sight lines and may be tailored on a crossing-by-crossing basis depending on existing topography, existing shrub cover, and the proximity of wetlands and rock outcrops which limit revegetation options:

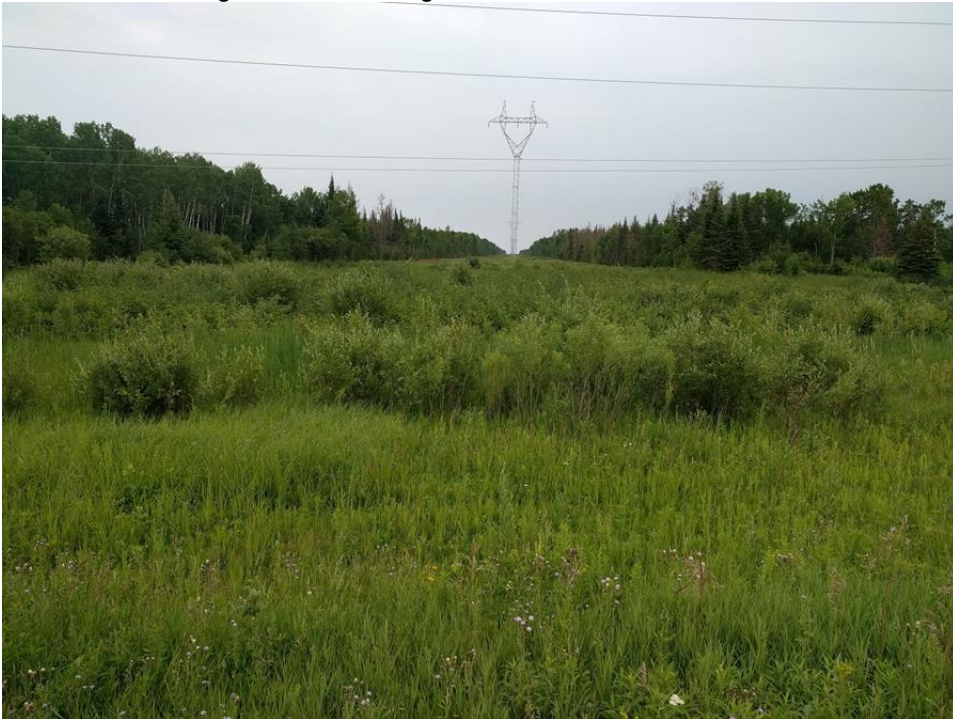
IMG_20170721_123106 – Willow shrubs which can provide visual barrier from Provincial Road #304 if allowed to grow to 5m in height.

- Transplanting of existing Willows from the edge of the RoW by excavating clumps (or the planting of potted stock) may be a good option for areas which do not have moist soils conducive to establishing cover from cuttings. The limitation with this approach will be finding areas with suitable soil depth.

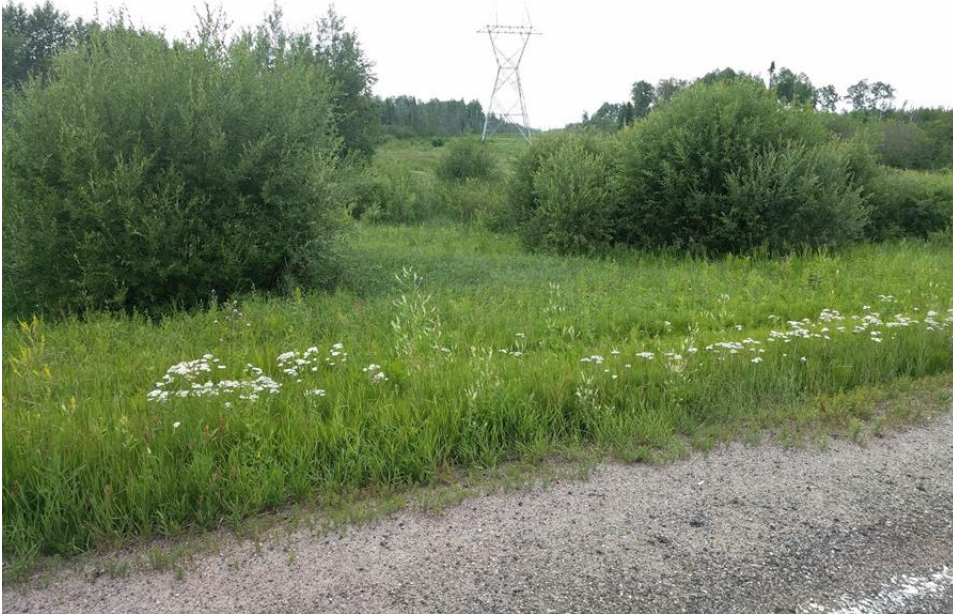
IMG_20170721_123315 – Effective visual barrier provided by mature Willow shrubs along Provincial Road #304 at a RoW highway crossing location.

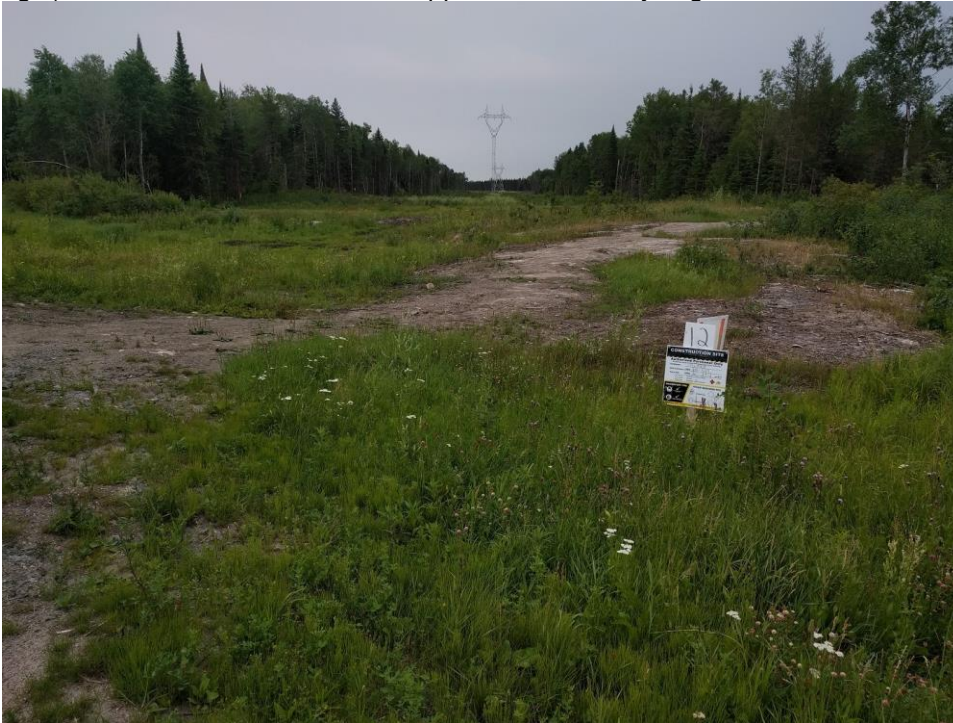
IMG_20170721_124536– Variable substrates (damp organic pocket to left and dry outcrop to right) will dictate which areas can support dense woody vegetation to create visual barriers.
