**Re: De-Activation of Dangerous Goods Handling and Transportation Act Licence 272
HW for Direct LP**

Direct LP recently authorized Amec Foster Wheeler Environment & Infrastructure (Amec Foster Wheeler) to complete an Environmental Assessment (EA) Report for the proposed relocation of the waste lead acid battery transfer station at 55 Rothwell Road in Winnipeg, Manitoba to 490 Lucas Ave in the RM of Rosser, Manitoba. This process has been completed, and a new licence (*Dangerous Goods Handling and Transportation Act Licence 295 HW*) has been issued by Manitoba Sustainable Development (July 29, 2016).

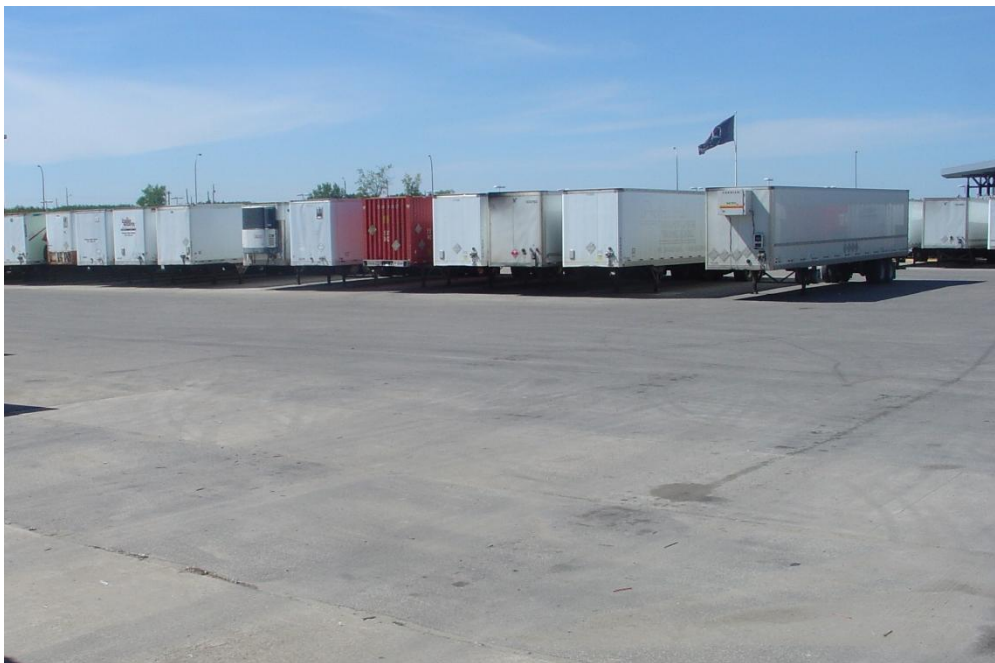
The tour began with an examination of the truck/trailer holding area. The area encompasses a large portion of the entire site, and is located on the south west portion of the property. This area is a loading/unloading waiting area for trailers, including any that were used in the transport of used batteries. The procedure was to keep a trailer in place until it was filled with batteries, and then a tractor would couple to the trailer and take it to the battery recycling facility in Calgary, Alberta. The time span for filling a trailer at the site was not recorded, but ranged from a few days to a few weeks, depending on the volume of used batteries. The holding area was

completely covered with a hard surface (concrete) that showed various levels of staining. None of the stained areas were identifiable as a result of the battery transportation operation, but were consistent with other high volume truck/trailer holding areas.

Figure 2: Trailer holding area. Note concrete surface, evidence of staining.

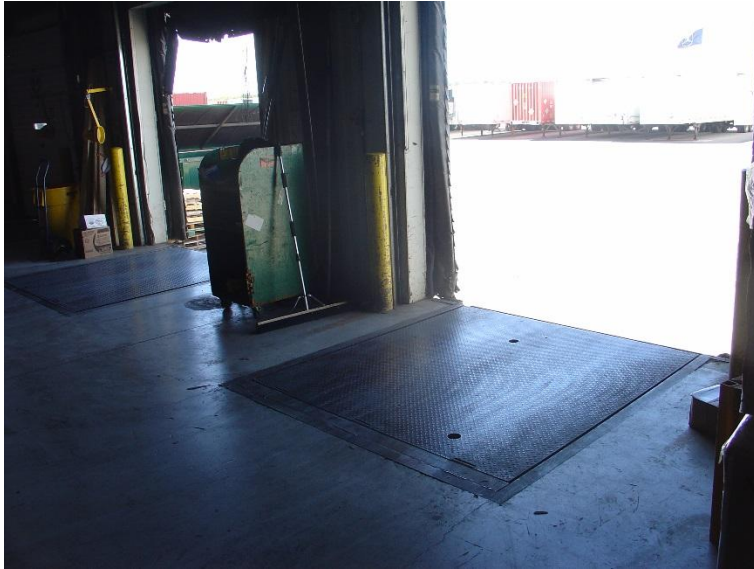
The shipping/receiving area for batteries was examined. Two separate loading docks were indicated to be the area where the batteries were placed on wooden pallets (“pallatized”), plastic wrapped, and loaded into the trailers. At the time of the site visit, no batteries remained and the area was being used for various (non-hazardous) shipping items. The concrete floor in the former battery area was similar to the floor throughout the docking area, with various markings and stains. No discernible pattern of staining that may have been related to battery handling was detectable.

Figure 3: Loading and unloading dock areas that were used for battery transfer.

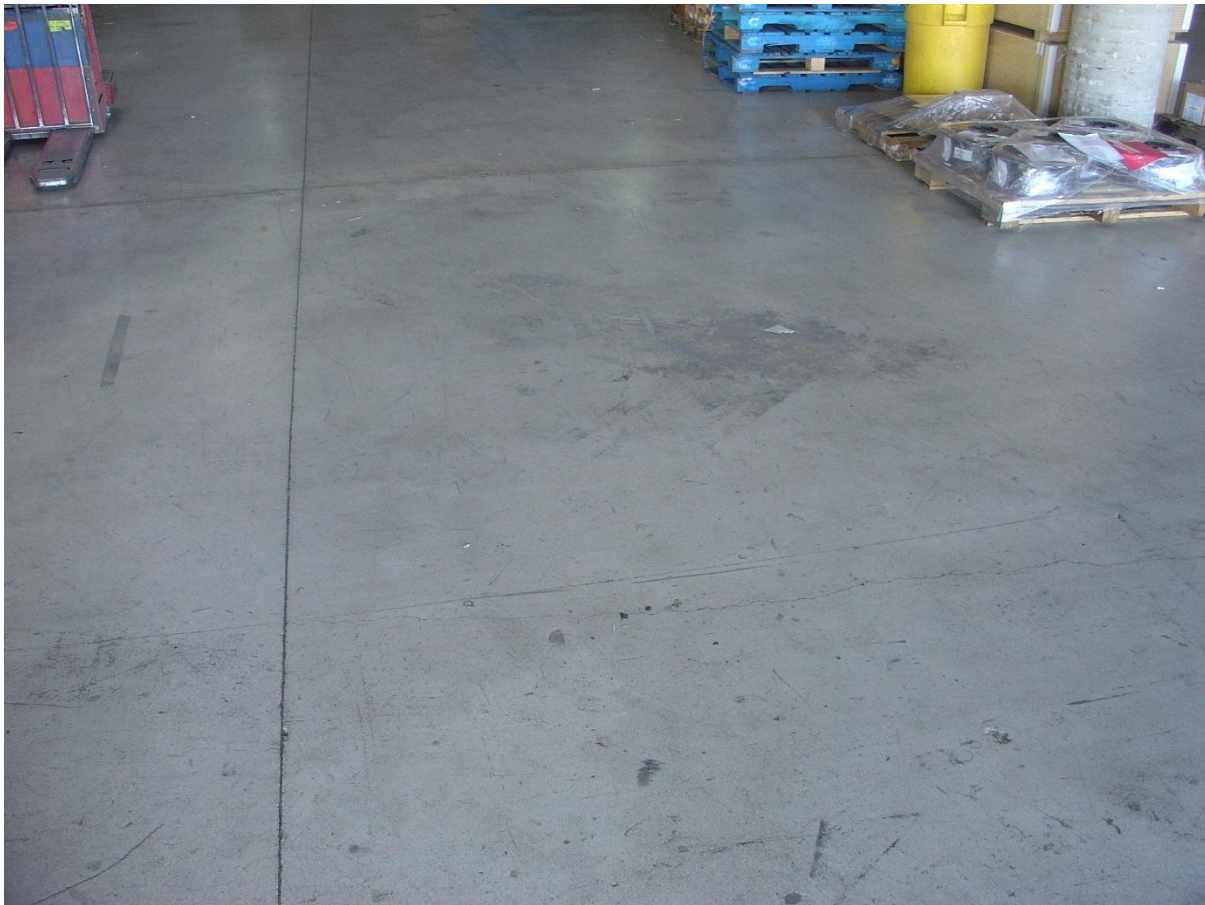
Figure 4: Floor in area where batteries were wrapped on pallets. Staining visible on floor is not related to battery operation.

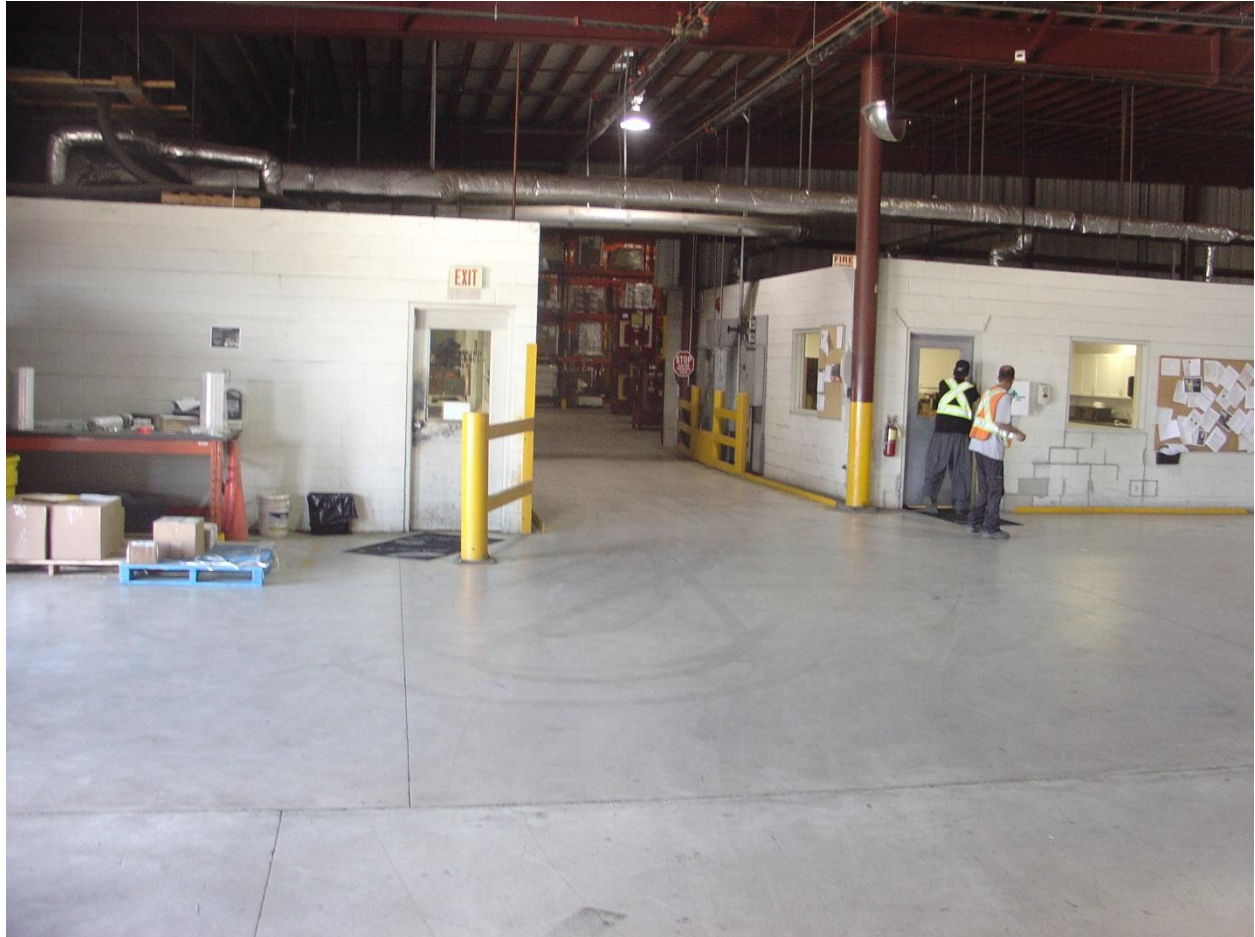
The area was in close proximity to office/work space areas that contained safety procedures related to the handling of hazardous materials. Bulletin boards clearly indicated spill procedures, required safety personal safety gear, and contacts in the event of an accident. Direct LP has an integrated safety and reporting system in place.

Figure 5: Area adjacent to former battery loading area. Safety bulletins and other information are available in this area.
