Notice of Alteration Form

Please find attached the Notice of Alteration Form and all required documentation in respect to attached Inspection Report for the Ethelbert Lagoon, dated October 16, 2020.

**RE: Ethelbert Lagoon Dike Assessment Letter Report**

JR Cousin Consultants Ltd. (JRCC) has completed this letter report assessing the Ethelbert wastewater treatment lagoon dike condition in response to an inspection conducted by Manitoba Conservation and Climate in October 2020.

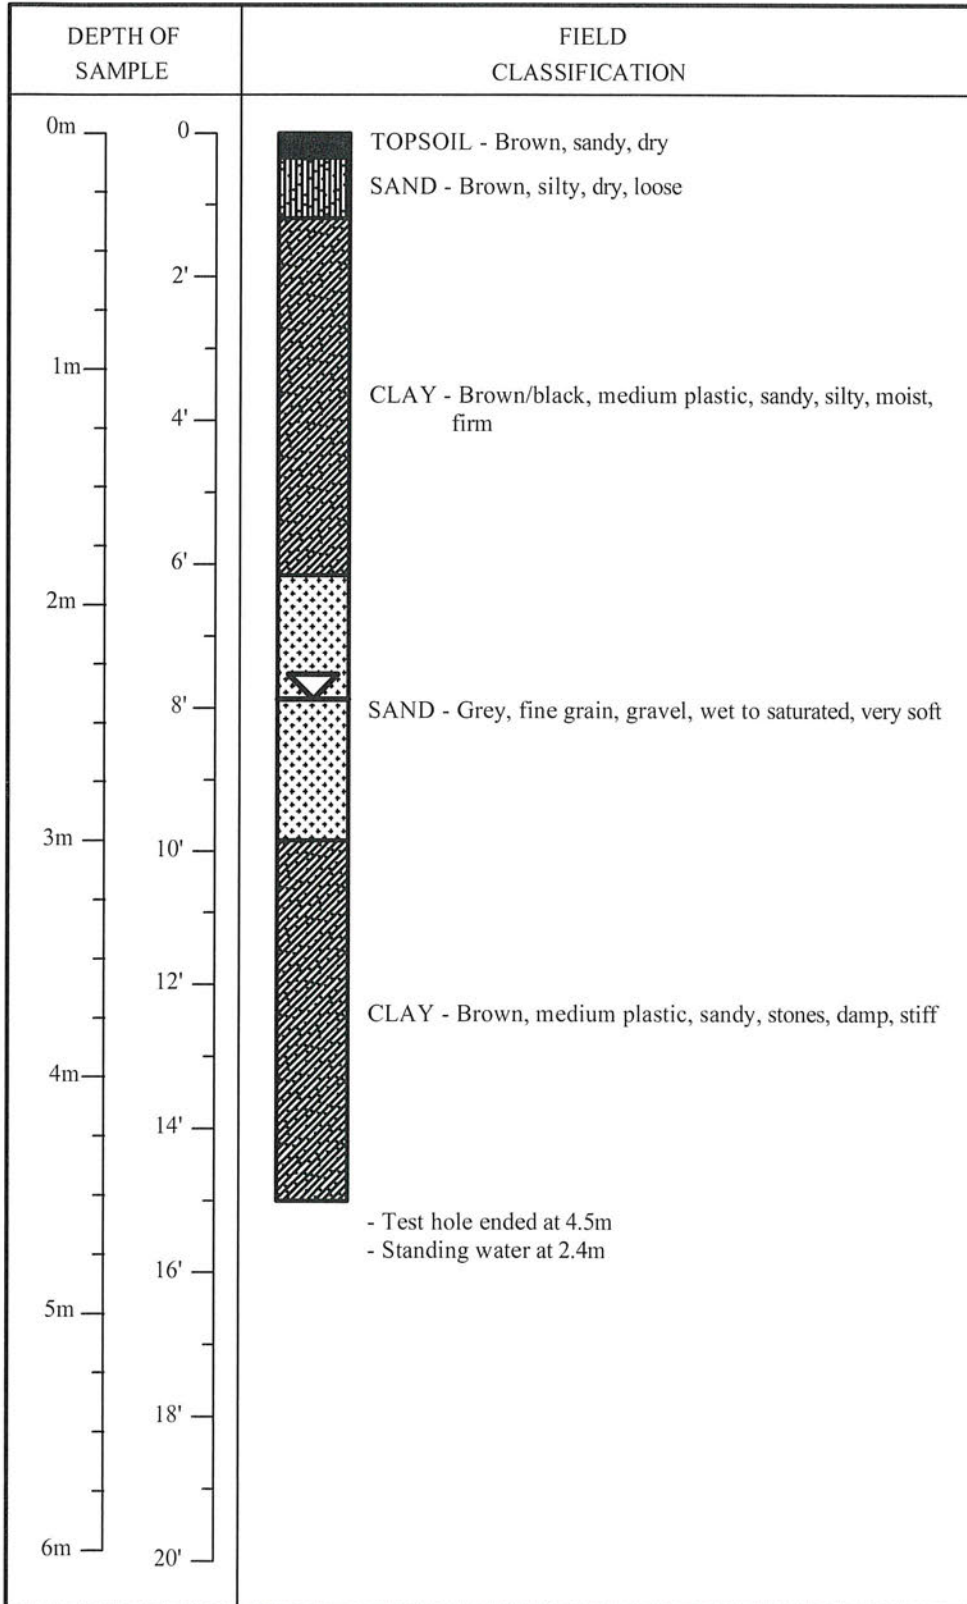
DATE : June 1, 2021  
 TEST HOLE # 2

The soil profile through the centre of the dike consisted of surficial sand, followed by a layer of medium plastic sandy clay to a depth of approximately 2.0 m below the top of dike. Underlying this is a layer of wet sand to a depth of approximately 3.0 m, followed by a layer of sandy clay. Groundwater was infiltrating through the sand layer at a depth of 2.0 m to 3.0 m below the top of dike.

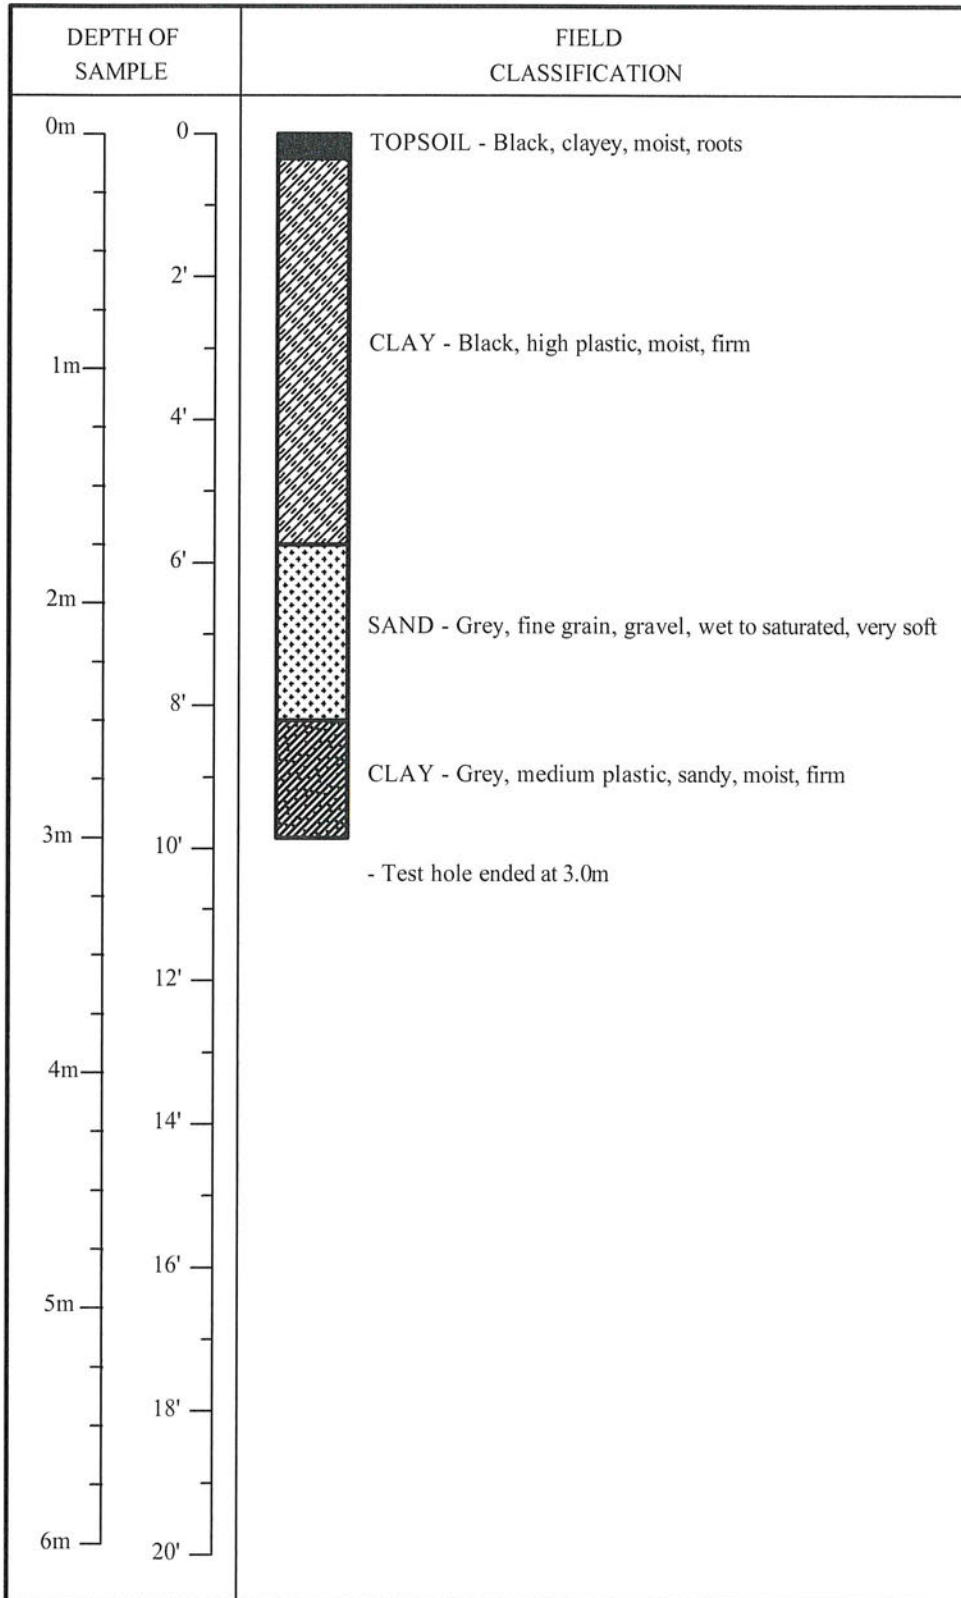
DATE : June 1, 2021  
 TEST HOLE # 4

The soil profile through the inner slope of the dike consisted of high plastic organic clay from the surface to a depth of 1.7 m, followed by a layer saturated sand and sandy clay. Groundwater was infiltrating through the sand layer at a depth of 1.7 m to 2.5 m below the surface.
